APN 221-021-023
Application Number 11021
Road Evaluation Narrative

HUMBOLDT COUNTY DEPARTMENT OF PUBLIC WORKS
ROAD EVALUATION REPORT

DATE: 13 October 2017
TO: Humboldt County Department of Public Works
FROM: Joel Monschke, Stillwater Sciences
SUBJECT: Road Evaluation for APN 221-081-004 (Blido Property):
Segment 1 - 1.7 miles of Humboldt County maintained Salmon Creek Road from
Maple Hills Road junction to Thomas Road turnout

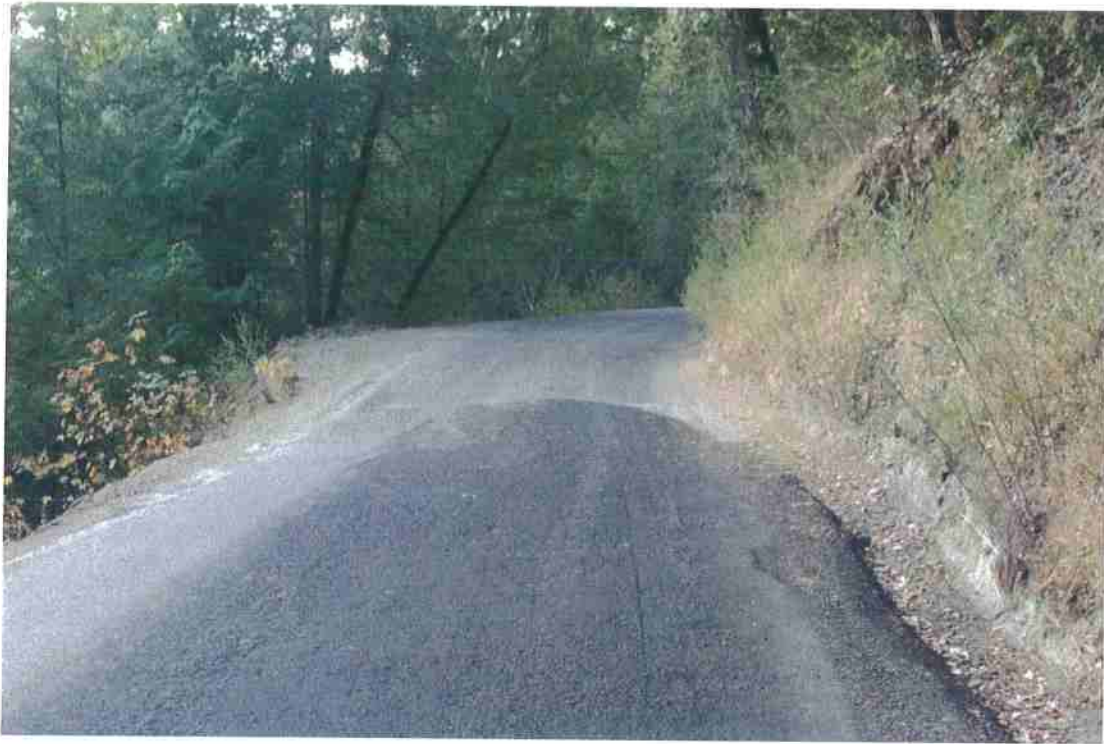
Photo 4. Mile 0.9: relatively narrow section, 15' width, 1' shoulders.

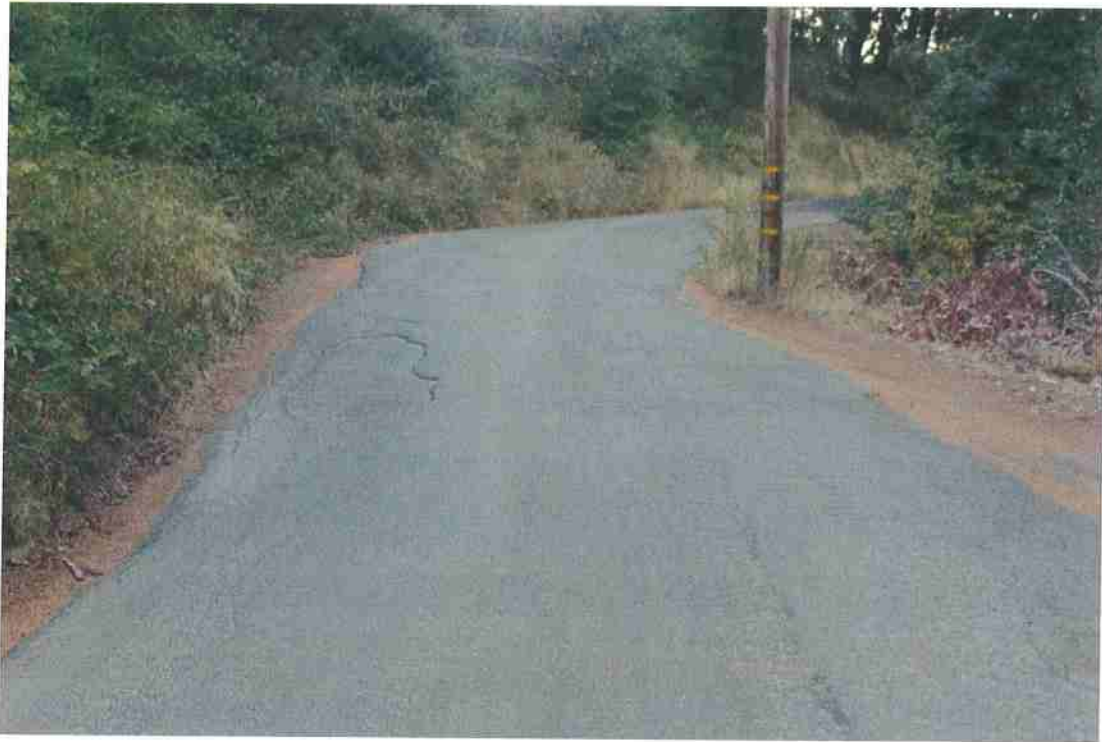
Photo 5. Mile 1.0: 18' width, 1' shoulder.

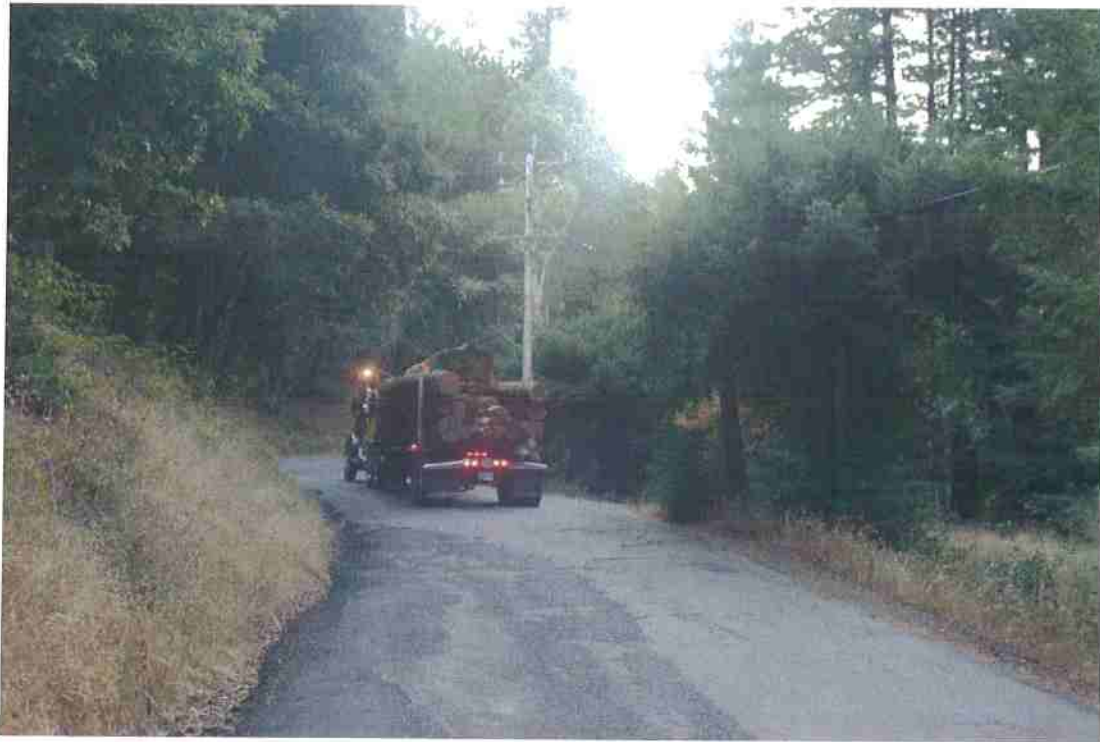
Photo 7. Mile 1.1: Logging truck on road.

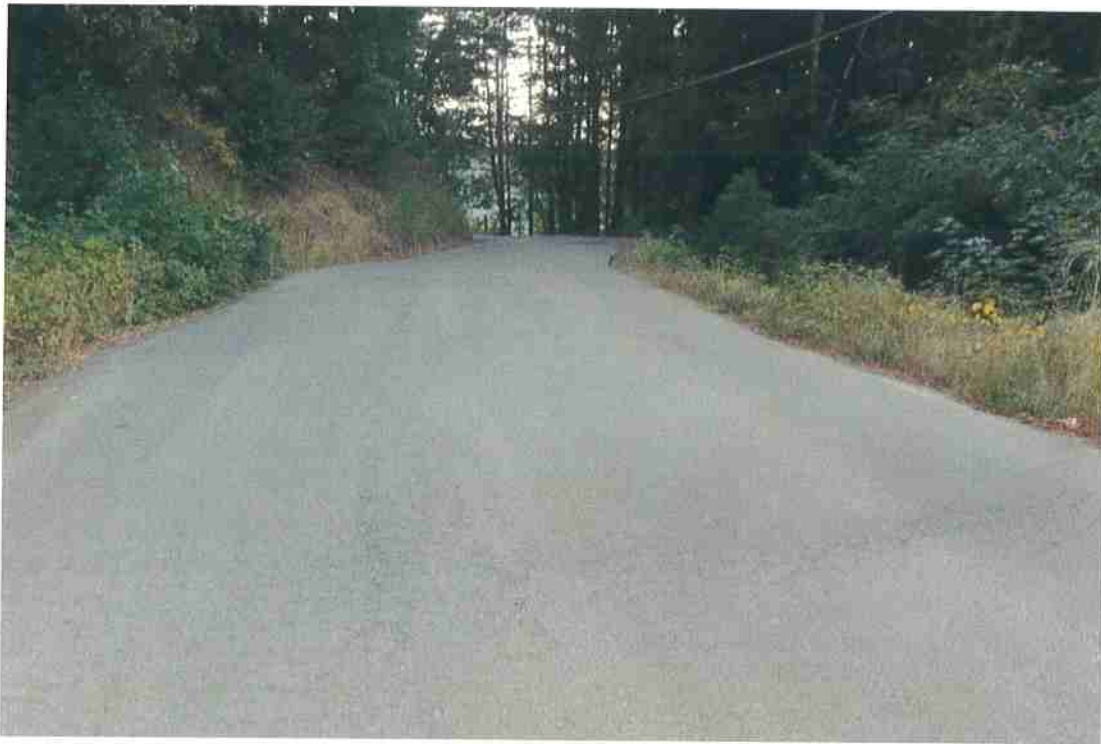
Photo 8. Mile 1.2: 24' width, 1' shoulders.

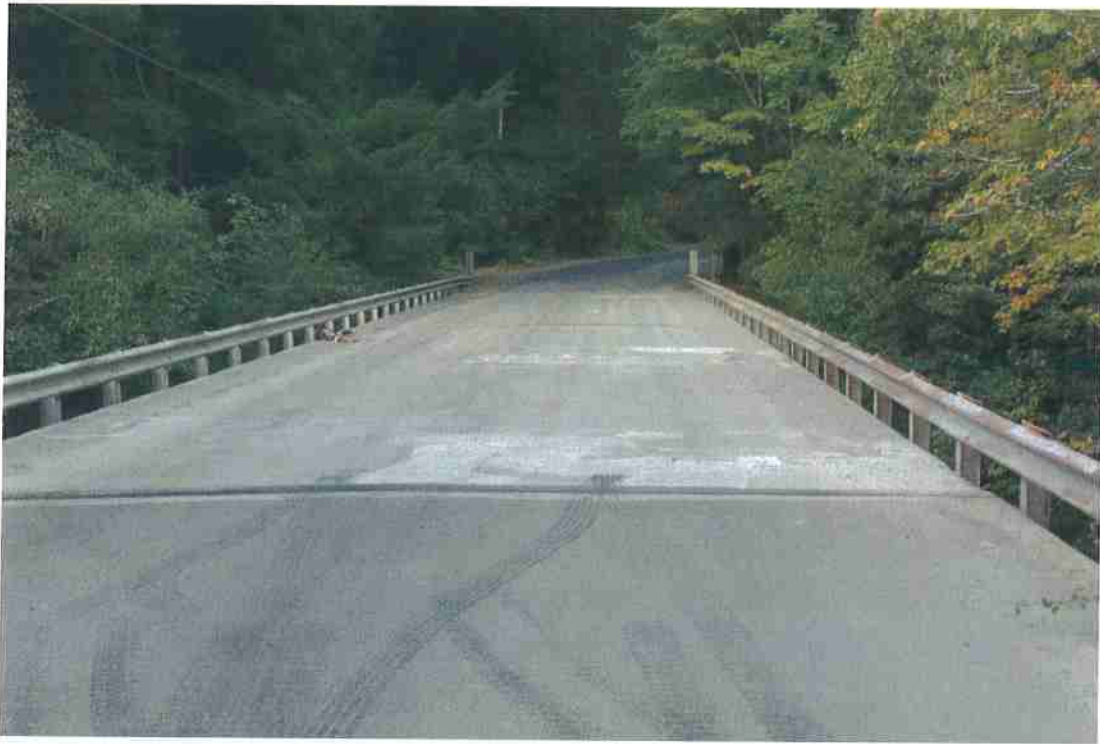
Photo 11. Mile 1.45: 28' width bridge, no shoulders.

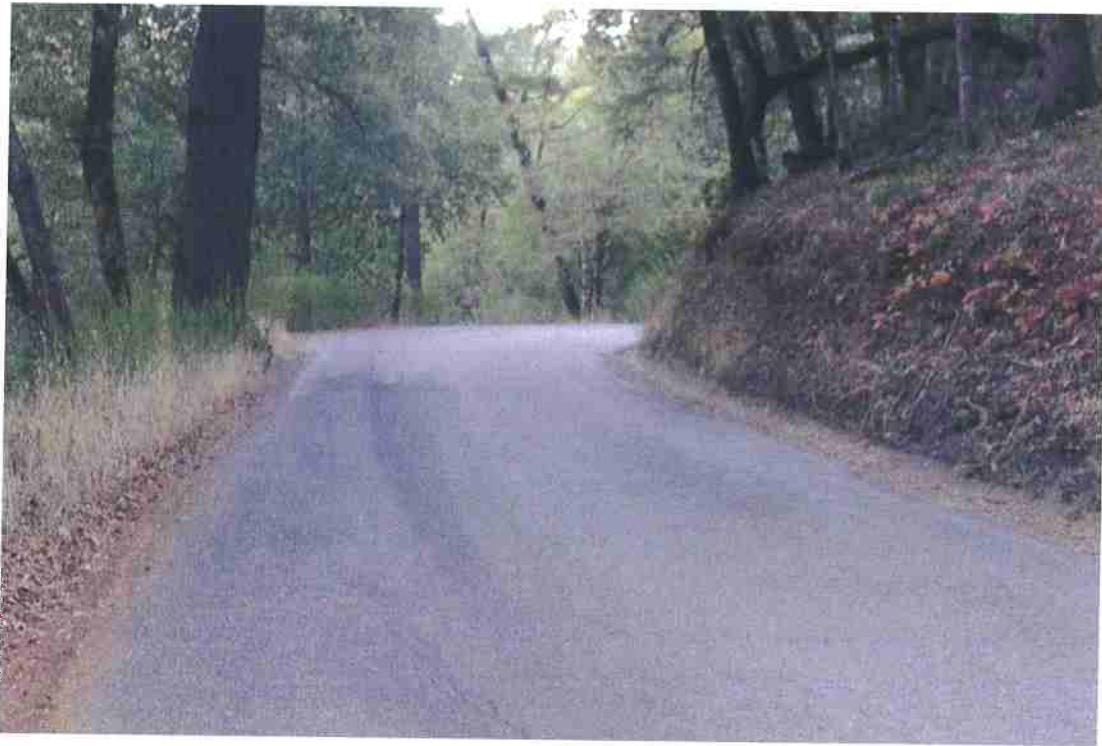
- Mile 1.0: 15-ft-wide pinch point with 1-ft shoulder caused by tree at blind corner.
- Mile 1.1: 20-ft road width with 1-ft shoulder.
- Mile 1.2: 20-ft road width with 1-ft shoulder.

Photo 11. Mile 1.0: Pinch point at tree on blind corner; 15-ft road width with 1-ft shoulder. Recommend widening.

- Mile 0.1: Cut vegetation to improve visibility, upgrade pavement to allow for minimal 18' wide driving surface width where feasible
- Mile 1.0: We recommend widening the roadway including removal of a Douglas Fir tree to improve the road width and visibility at the blind corner.
- Mile 1.9 to mile 2.2: There are some pinch points along this segment, but the segment traverses steep terrain so widening would be difficult and have potentially significant environmental impacts. Recommend signage reminding drivers to slow down and stay on their side of the road.
- Mile 2.4: We recommend widening the corner on the inside to improve width and visibility at the blind corner. Also nearby at mile 2.35, need to repair slumping outboard edge of road.

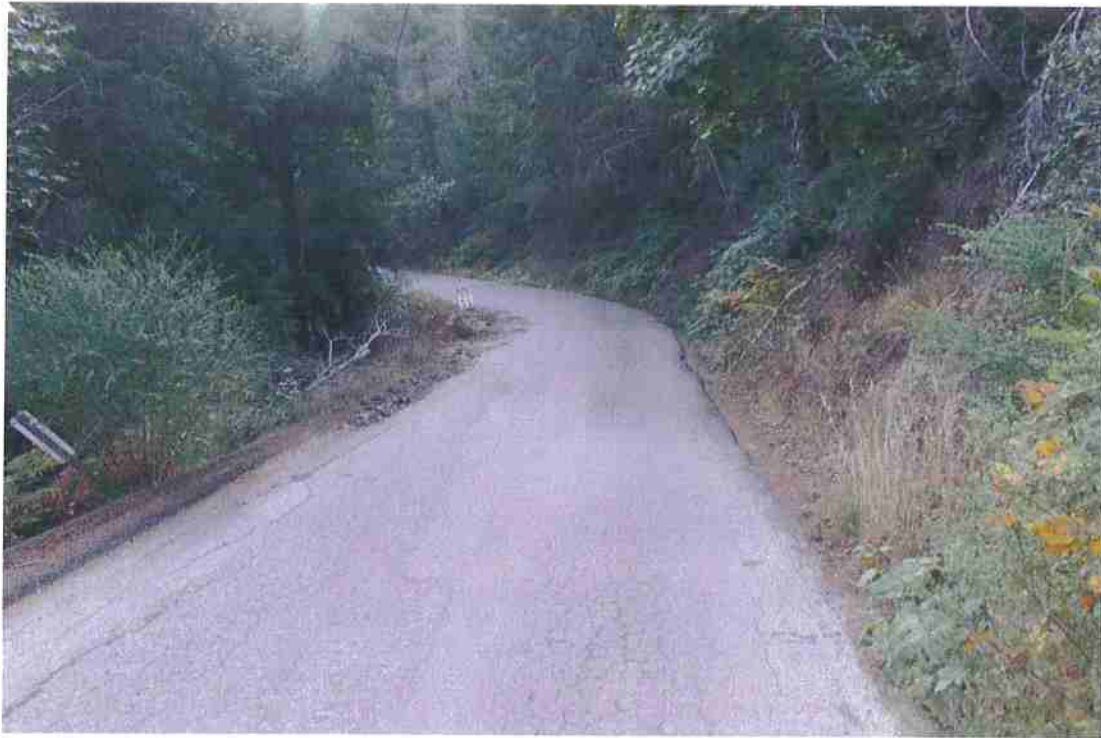
- Mile 2.3: 20-ft road width with 2-ft shoulder.
- Mile 2.35: ~15-ft-wide pinch point at partial road failure
- Mile 2.4: 16-ft road width with 1-ft shoulder. Dangerous blind corner.

Photo 26. Mile 2.35: ~15-ft road width pinch point at partial road failure.

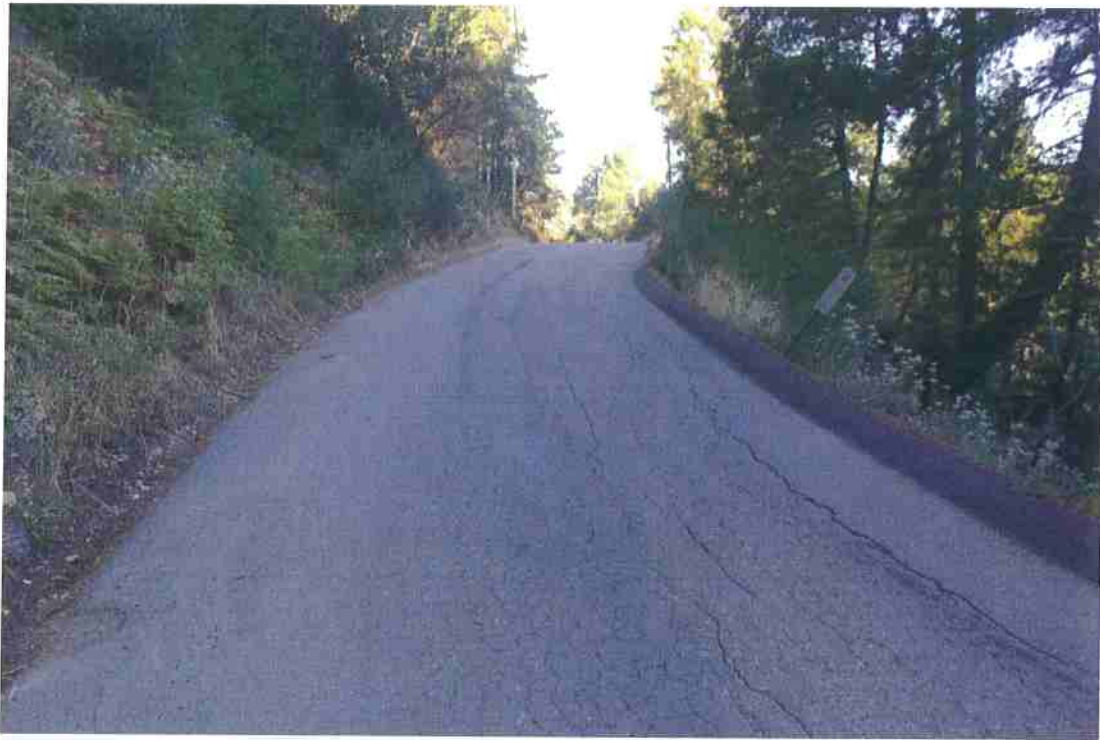
Photo 27. Mile 2.37: ~15-ft road width pinch point past partial road failure.

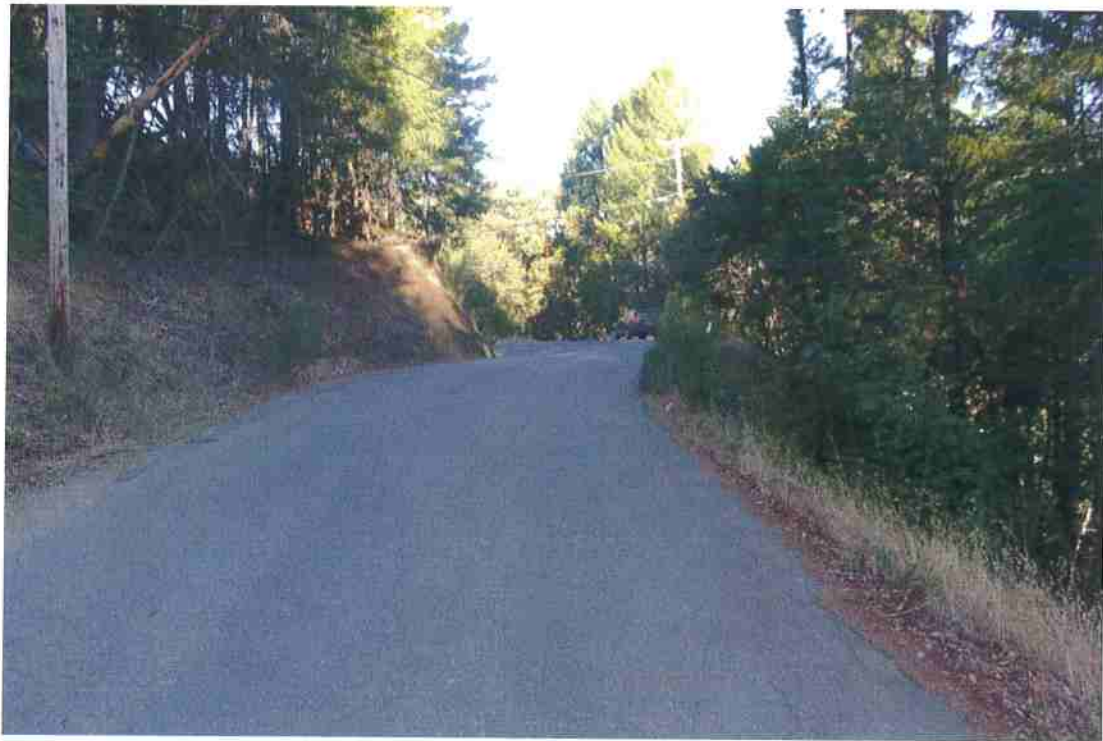
Photo 28. Mile 2.4: 16-ft road width with 1-ft shoulders at blind corner. Potential spot to widen corner on the inside to improve width and visibility.

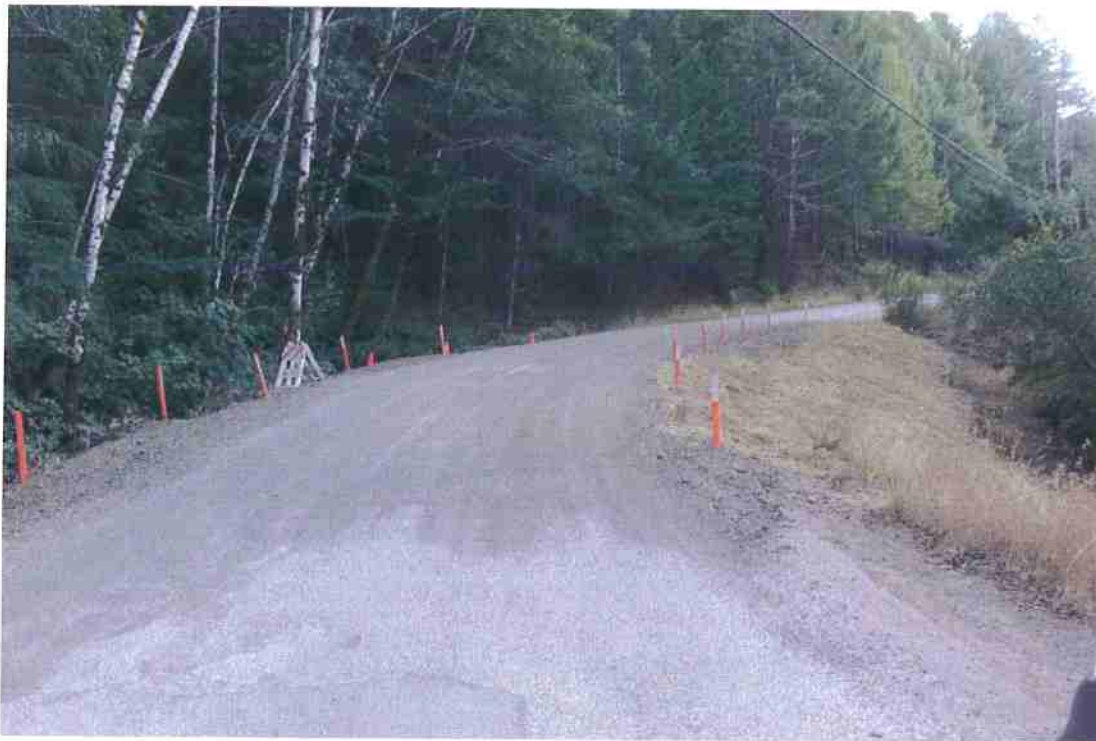
- Mile 2.6: The culvert at this location was recently repaired. The short segment over the culvert is gravel and 18-ft wide with 2-ft shoulder.
- Mile 2.7: 20-ft road width and 2-ft shoulder.

Photo 30. Mile 12.6: Recent culver repair, short gravel segment. 18-ft road width with 2-ft shoulders.

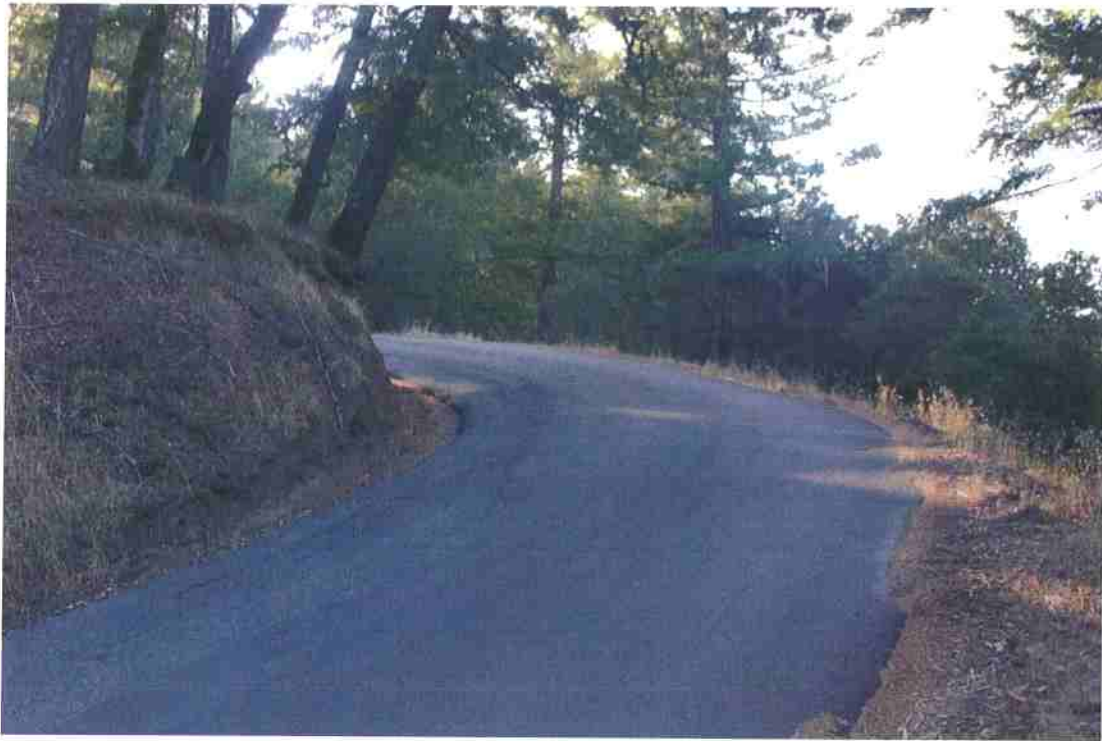
Photo 36. Mile 3.15: Dangerous pinch point at blind corner. 15-ft road width with 1-ft shoulders. Potential spot to widen corner on inside to improve width and visibility.

- Mile 3.15: We recommend widening corner on inside to improve road width and visibility on dangerous blind corner. This is probably the most dangerous corner on the road.

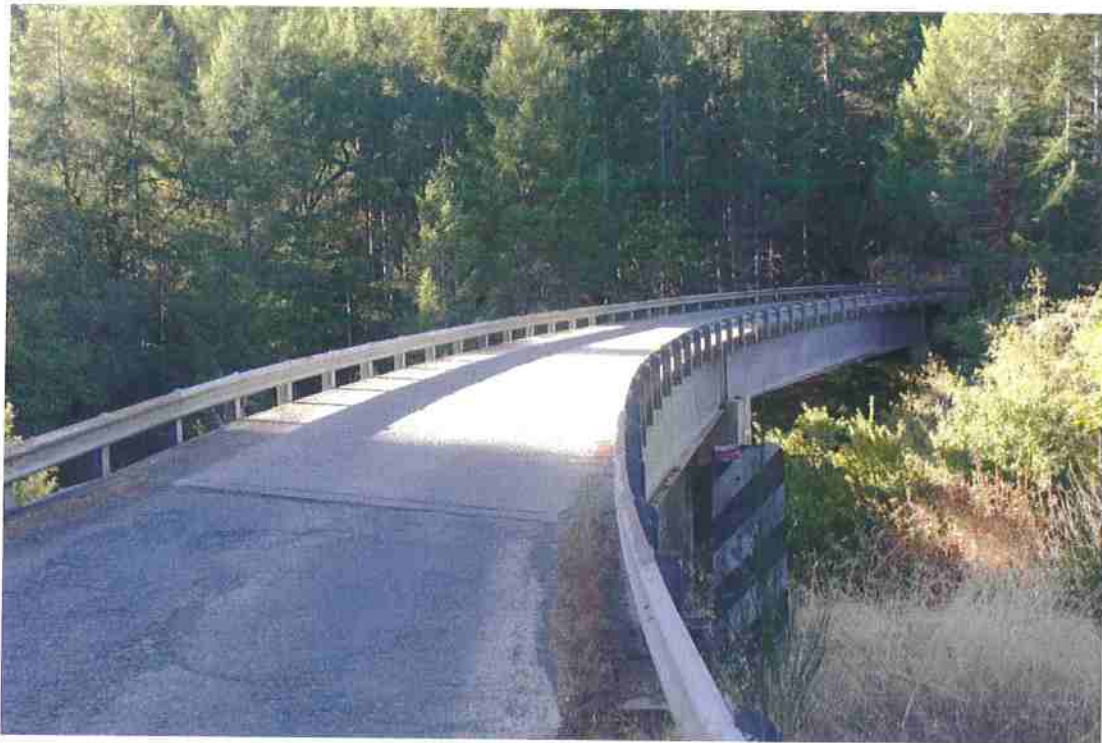
Photo 38. Mile 3.3: 16-ft wide bridge, no shoulders. Recommend removing vegetation on west extent of bridge to improve visibility.

- Mile 3.3: We recommend removing vegetation on western extent of bridge to improve visibility.
- Mile 3.4: We recommend widening corner on inside to improve width and visibility at blind corner.

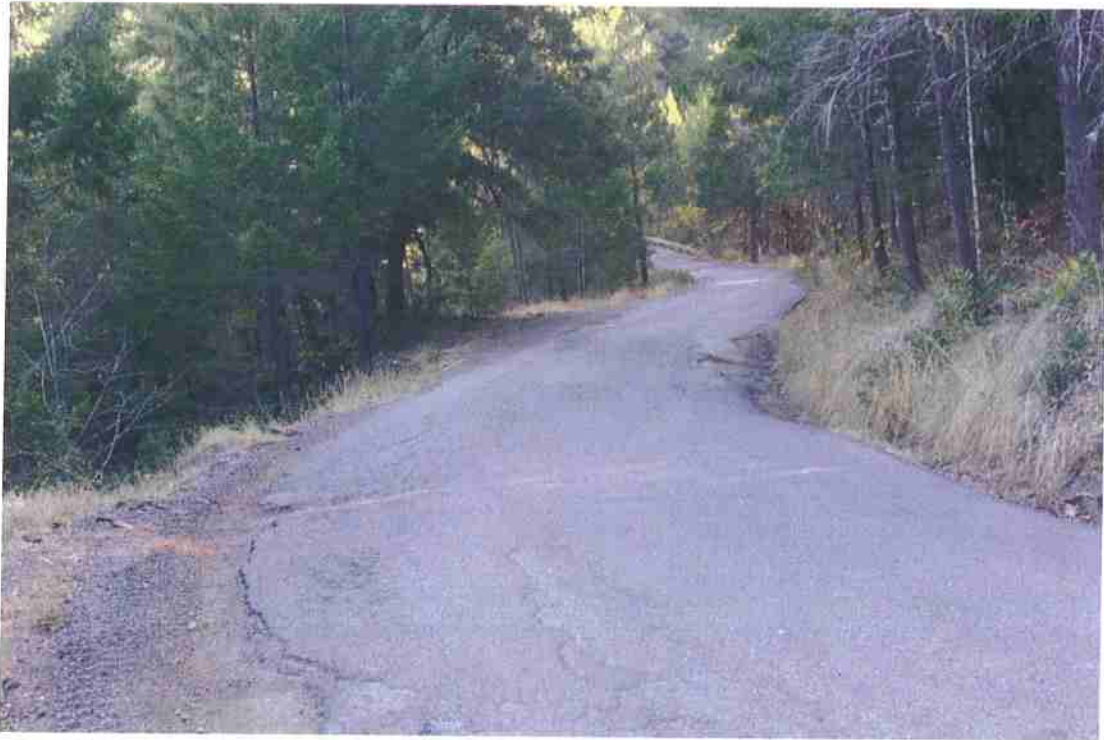
Photo 39. Mile 3.4: 16-ft road width with 1-ft shoulder. Pinch point at downgradient extent of blind corner. Potential spot to widen corner on inside to improve width and visibility.

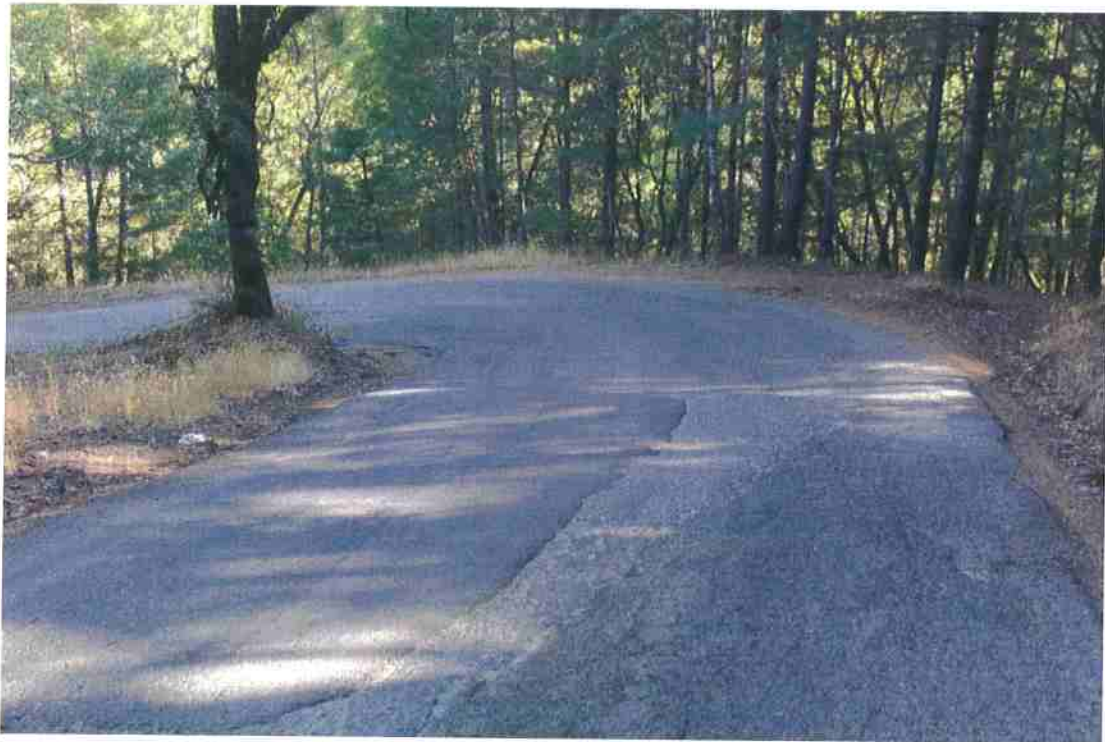
Photo 40. Mile 3.5: 18-ft road width with 1-ft shoulder. Very steep, sharp corner where trucks often get stuck. Consider re-engineering grade and curve radius.

- Mile 3.5: Although the width and visibility on this corner is adequate, it is very steep and dangerous because large trucks frequently get stuck. We recommend re-engineering the corner to reduce grade and lengthen radius of curve. This work could potentially utilize the cut material from the other road widening sites.

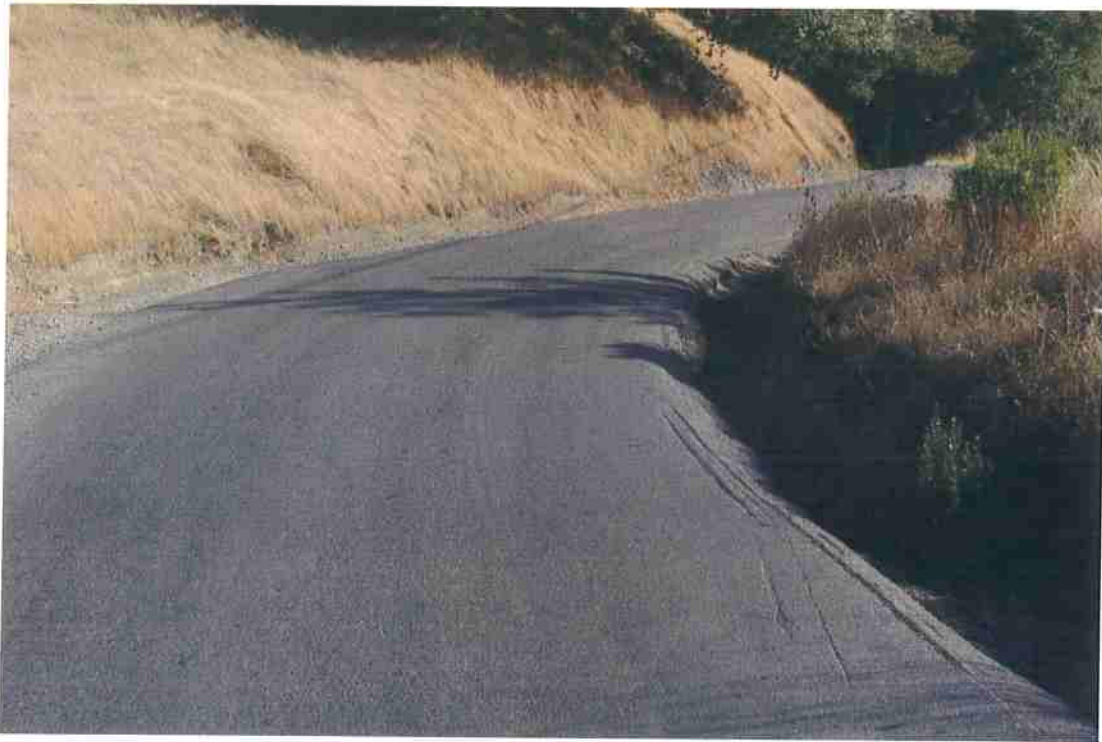
- Mile 3.7: 12-ft road width with 10ft shoulder. Partially blind corner with deep ditch.
- Mile 3.8: 18-ft road width with 1-ft shoulder.
- Mile 3.9: 15-ft road width with 2-ft shoulder, broken pavement edges make segment more treacherous.

Photo 43. Mile 3.7: 12-ft road width with 1-ft shoulder. Partially blind corner with deep ditch. Potential spot to widen corner on inside to improve width and visibility.

- Mile 3.65 to mile 3.7: Potential locations to widen several corners on inside to improve road width and visibility at blind curves.
- Mile 3.7: Potential location to widen corner on inside to improve road width and visibility at partially blind curve.

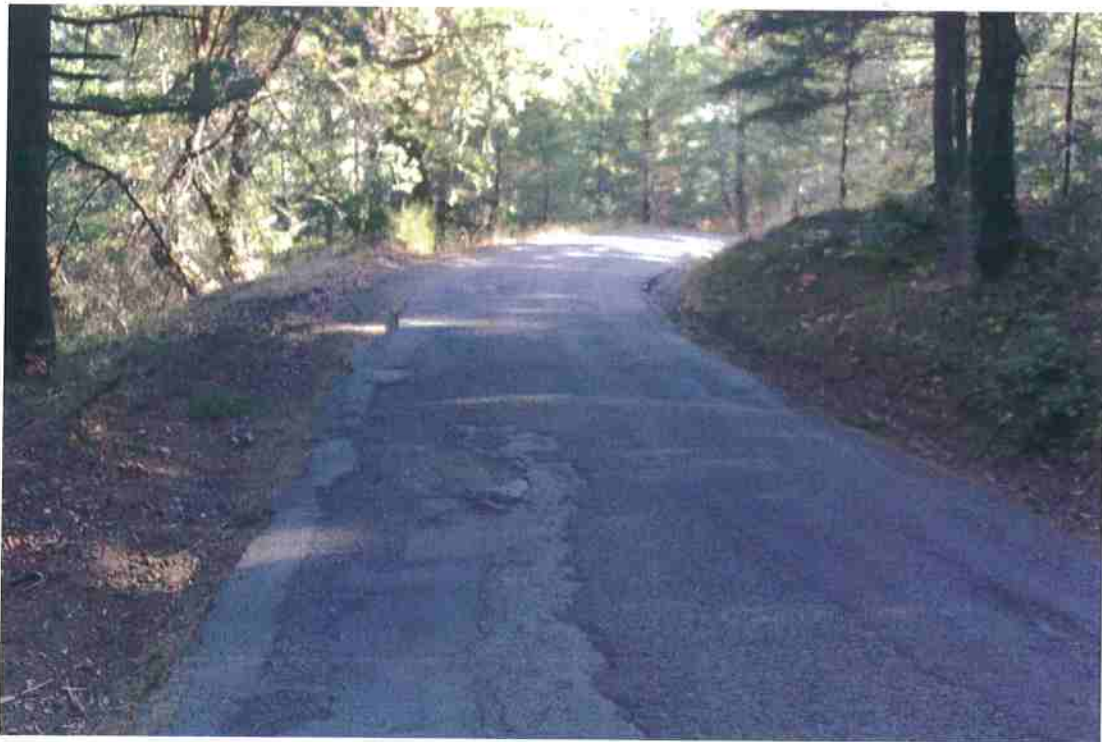
Photo 46. Mile 3.9: 15-ft road width with 2-ft shoulders. Broken pavement edges make segment more treacherous.

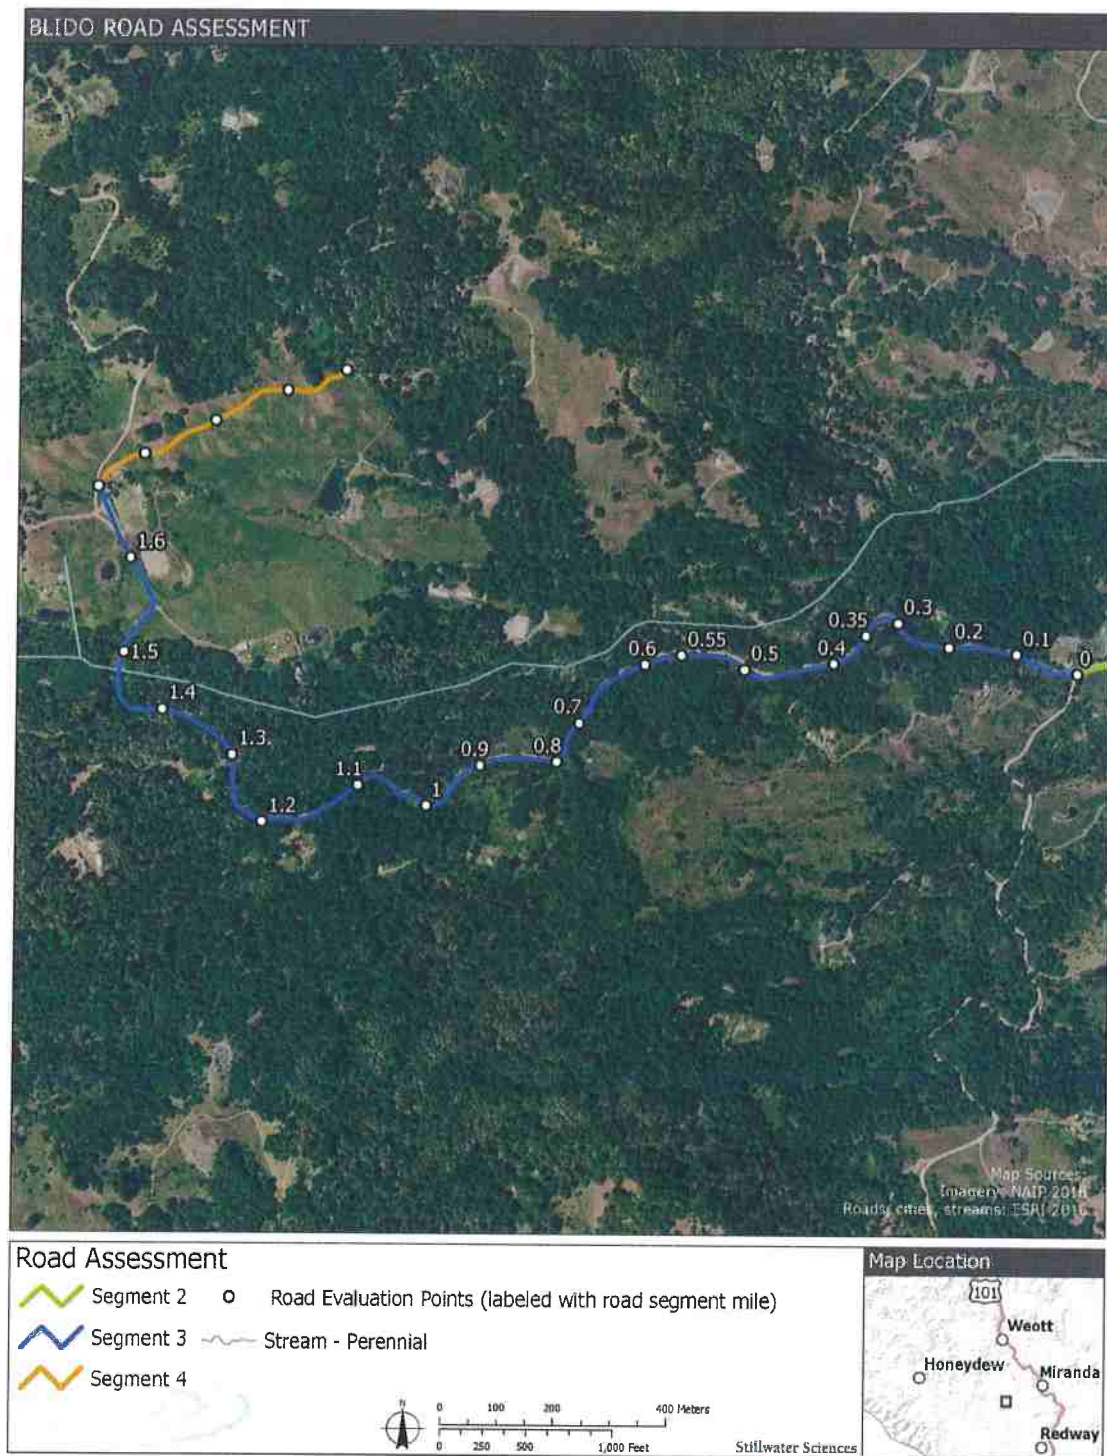
Figure 2. Road Segments 2-4 map.

Overall, the 1.7 miles of County Road is in relatively good condition. The greatest safety concerns on the segment are pinch points at various culvert crossings but the visibility in this segment is adequate and only one pinch point is located at a blind corner. With the exception of this one pinch point, this road segment functions as "equivalent to a category 4 road".

- Mile 0.35: replace culvert to widen road at pinch point. Armor inboard ditch to eliminate erosion of the road. Note that this is a moderate priority as compared to the recommendations in Segment 2 (County-maintained Thomas Road).

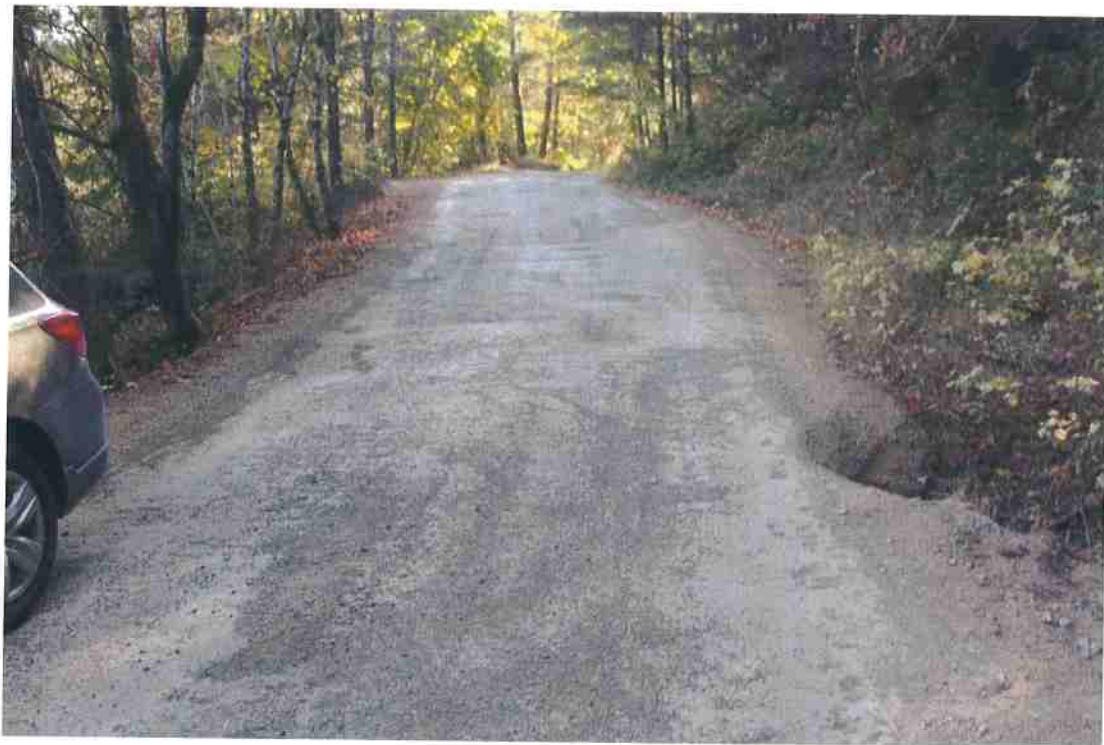
Photo 2. Mile 0.2: 16-ft road width with no shoulder at culvert crossing. The road could be widened at the culvert but there is decent visibility at the site so widening is not necessary.

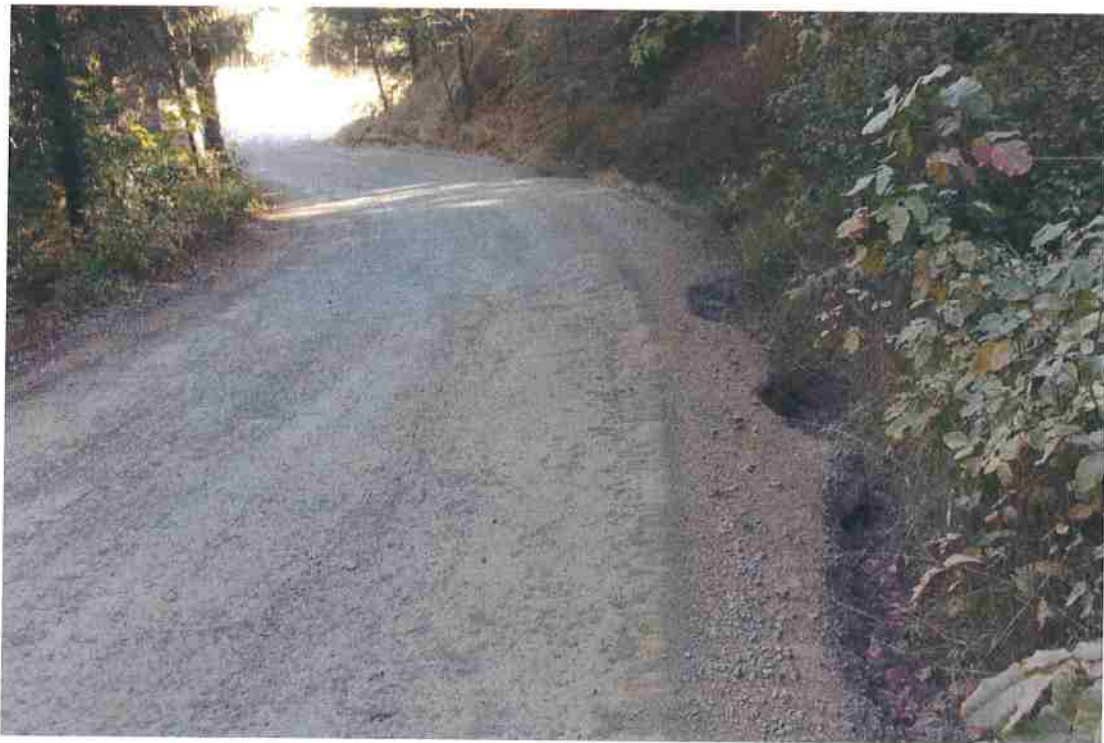
Photo 4. Mile 0.35: Inboard ditch eroding into road.

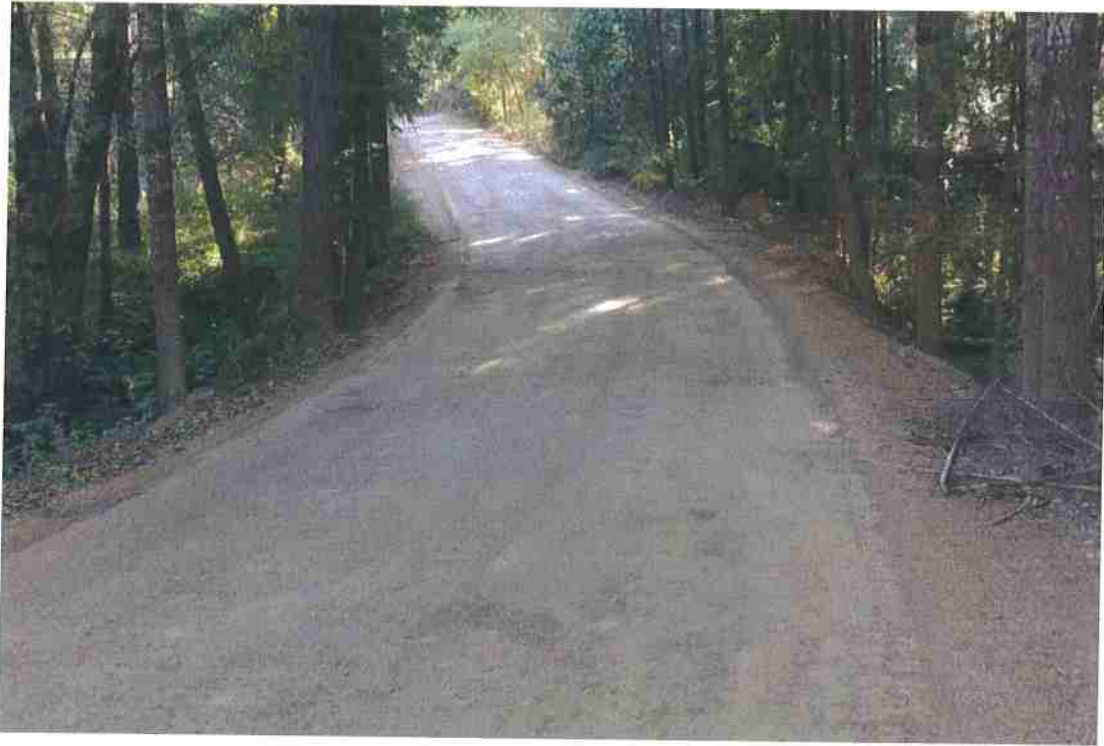
Photo 15. Mile 1.2: 18-ft road width with no shoulder at culvert crossing with decent visibility.
