Site Management Plan

(Tier 1, Low Risk)

APN: 107-251-003

WDID- 1_12CC402535

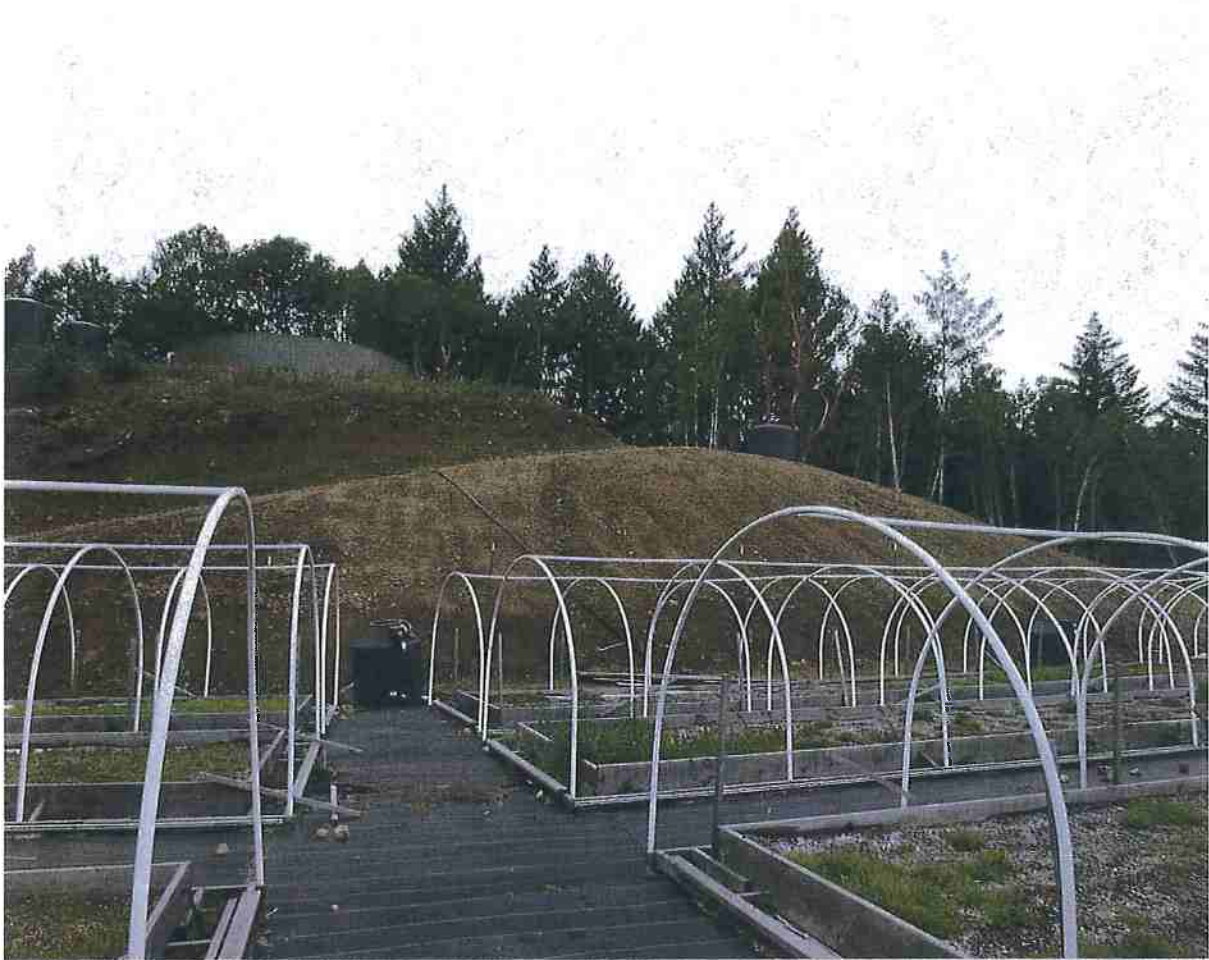
Photo #1: Upper Cultivation Area A, with a 100' x 20' cut bank, with numerous rills. Photo Date: 2/07/2019.

The Cultivator has limited and prevented erosion by, rock surfacing the permanent access road, from the gate at Wilder Ridge Road, up to the residence. Water bars have been placed on the seasonal use access road, following the recommended surface drainage break frequency. The Cultivator has prevented erosion by limiting the use of vehicles during the wet season and maintaining the water bars annually. No wheel ruts were observed in the seasonal use road. In the future, the Cultivator shall use measures prescribed in the BMP, to address the rills in the cut bank, above Cultivation Area A. Apply to the entire cut slope, a native seed mixture and mulching with either straw or wood chips. Additionally, jut matting can be placed on the cut slope, in order

to keep seed in place and establish adequate vegetation. See the Mitigation Report, Treatment Implementation Schedule, and Site Map to follow for site specific details.

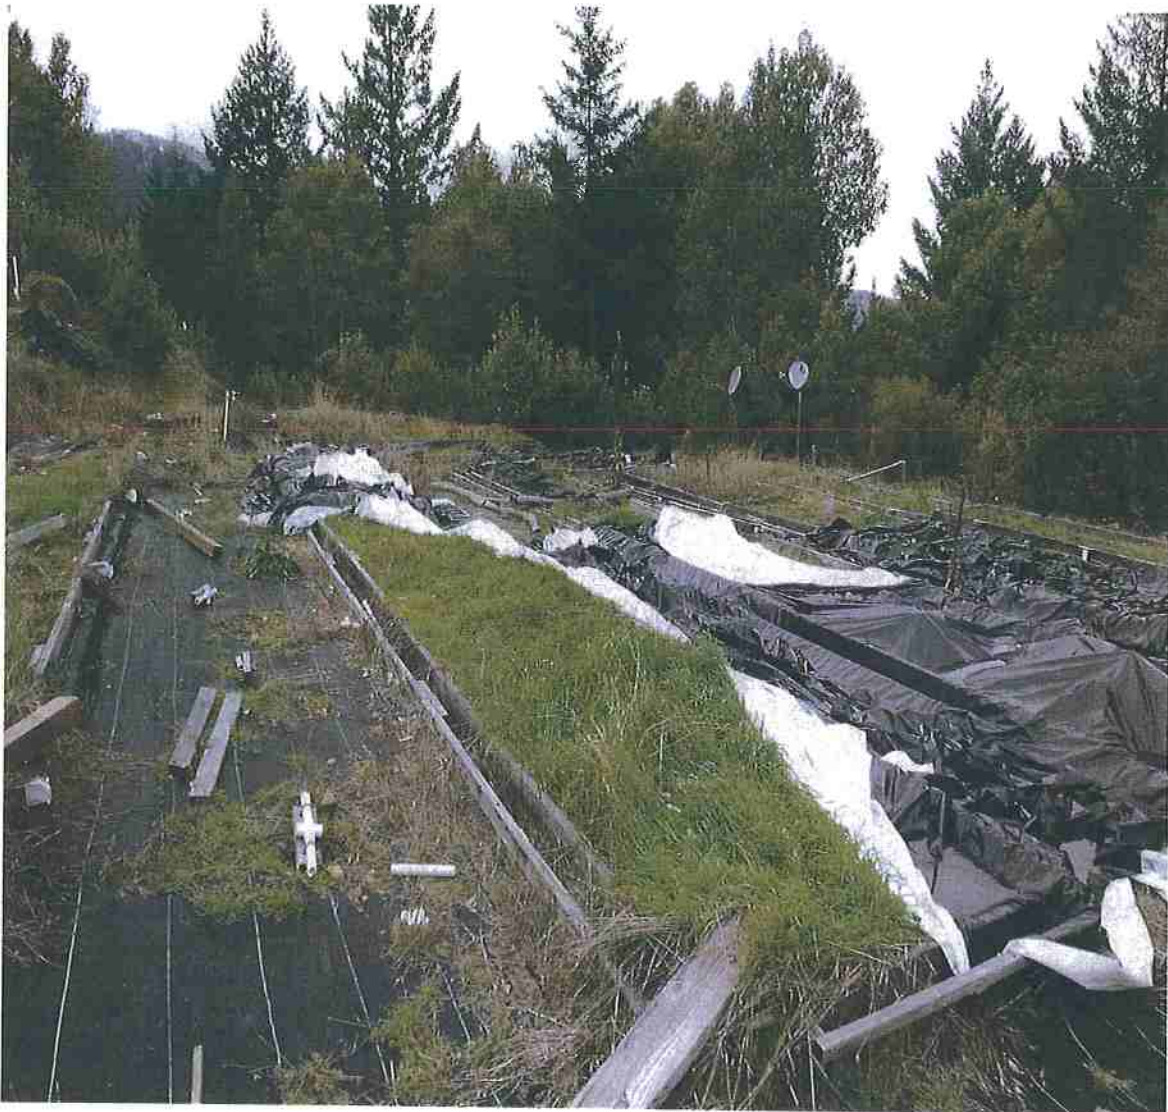
*Photo #2: Abandon Cultivation Area C, just north of residence. Cultivation related materials, still present.
Photo Date: 02/07/2019.*

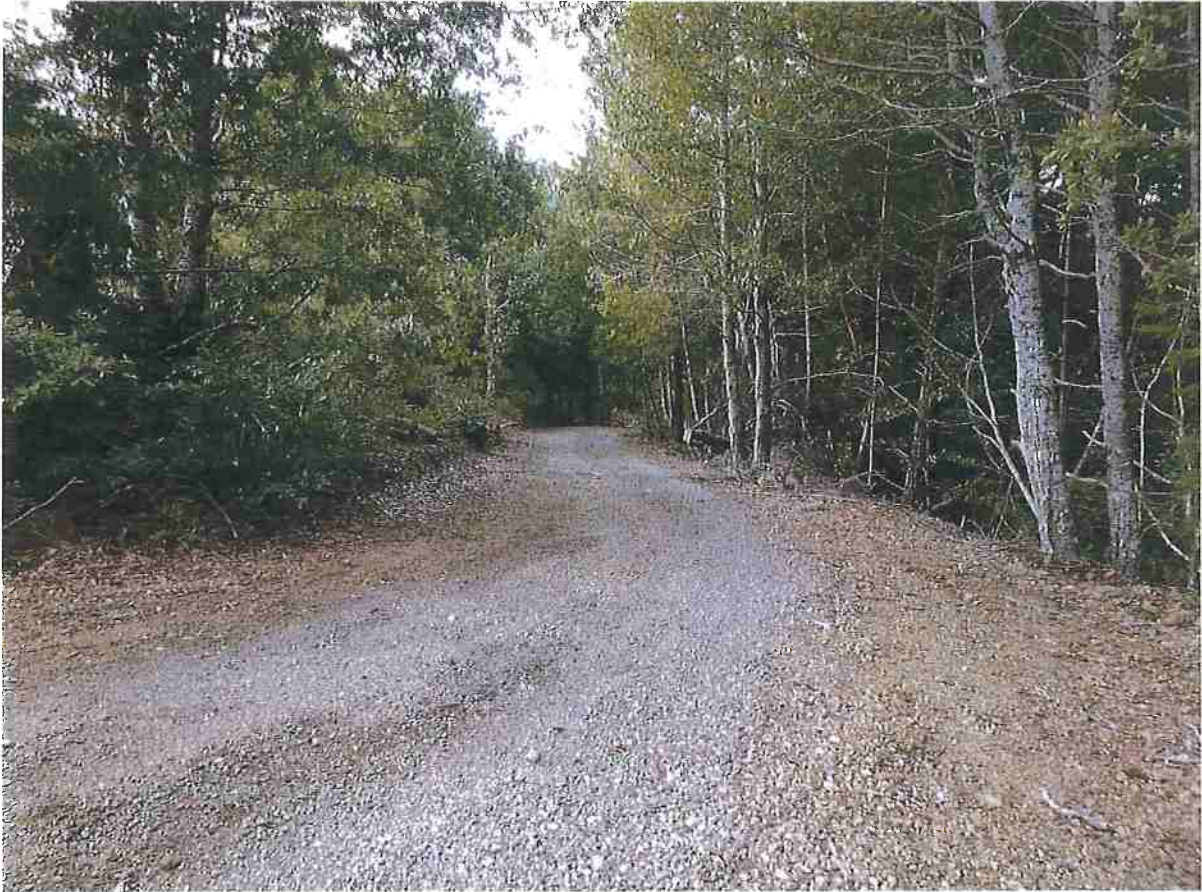
Photo #2: Permanent access road, with adequately rocked surface, leading up to residence.
Photo Date: 02/07/2019.
