ADA Access Barrier Assessment Report For

**Pro Building
507 F Street
Eureka, CA 95501
Last Updated 8/14/2023**

ACCESSIBILITY COMPLIANCE ASSESSMENT REPORT

507 F Street, Eureka, CA – CASp Assessment II

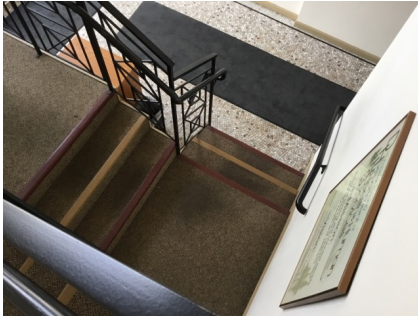
3C

Accessibility Element: Stairways

Specific Item: Contrasting Stripe

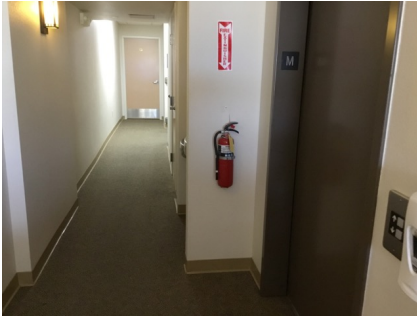
7F

Accessibility Element: **Protruding Objects**

Specific Item: **Protruding Object**

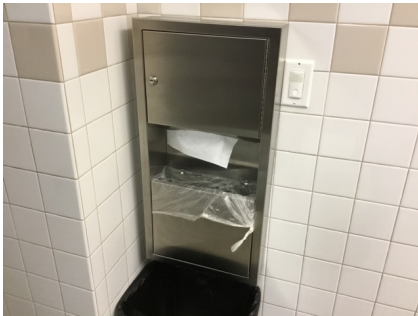
8I

Accessibility Element: Toilet and Bathing Rooms

Specific Item: Accessories

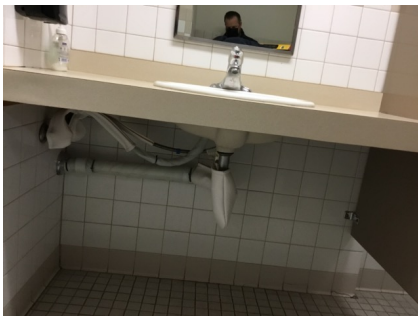
8L

Accessibility Element: Lavatories and Sinks

Specific Item: Exposed Pipes and Surfaces

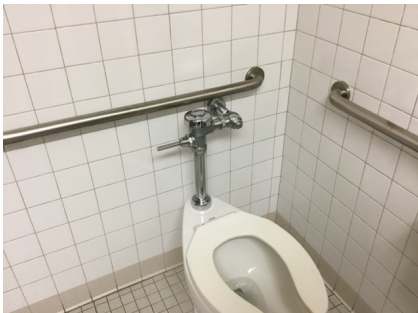
8Q

Accessibility Element: Operable Parts

Specific Item: Operation

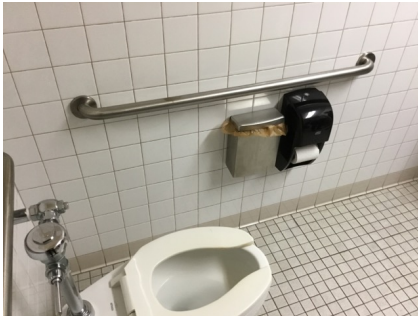
8S

Accessibility Element: Water Closets & Toilet Compartments

Specific Item: Side Grab Bar

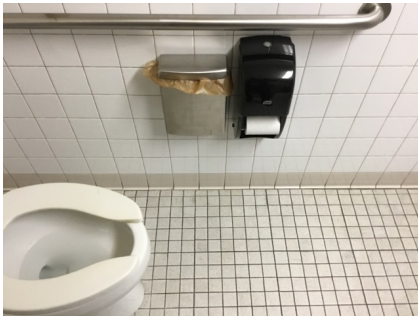
8T

Accessibility Element: Water Closets & Toilet Compartments

Specific Item: Toilet Paper Dispenser

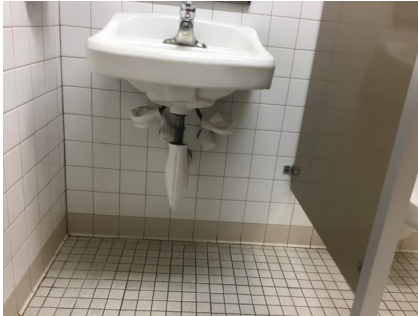
9K

Accessibility Element: Lavatories and Sinks

Specific Item: Exposed Pipes and Surfaces

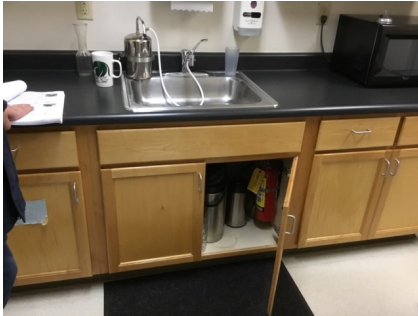
14C

Accessibility Element: Lavatories and Sinks

Specific Item: Height & Knee Clearance

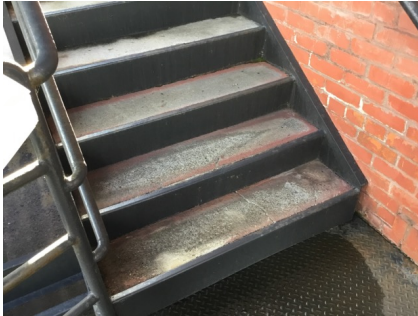
22D

Accessibility Element: Stairways

Specific Item: Contrasting Stripe

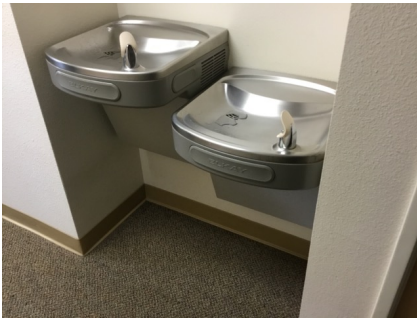
23B

Specific Item: Clear Floor Space

Barrier Description:
Drinking fountain does not provide a min. 30" wide by 48" long clear floor space and/or the clear floor space is not centered on the unit.

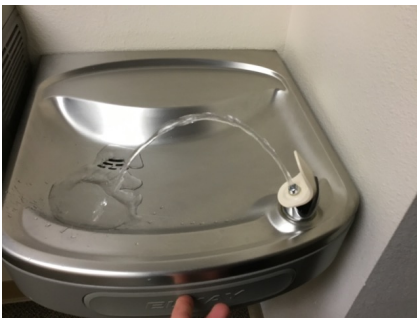
23C

Specific Item: Water Flow

Barrier Description:
Water flowing from spout is less than 4".

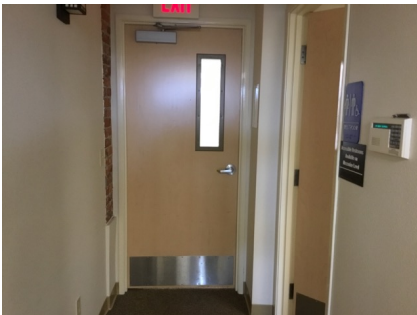
23G

Specific Item: Maneuvering Clearance

Barrier Description:
Front Approach, Pull Side: Door does not provide a minimum 60" long (measured perpendicular to doorway) x 18" wide (measured beyond latch side) maneuvering clearance (Exterior doors shall instead provide a minimum 24" wide clearance on exterior sides).

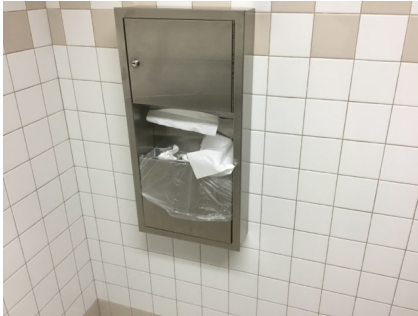
24E

Accessibility Element: Protruding Objects

Specific Item: Protruding Object

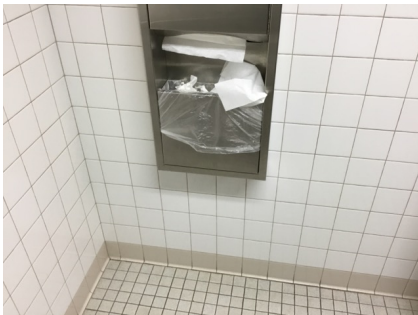
24G

Accessibility Element: Toilet and Bathing Rooms

Specific Item: Accessories

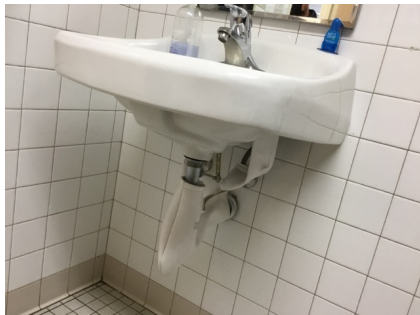
24I

Accessibility Element: Lavatories and Sinks

Specific Item: Knee Clearance

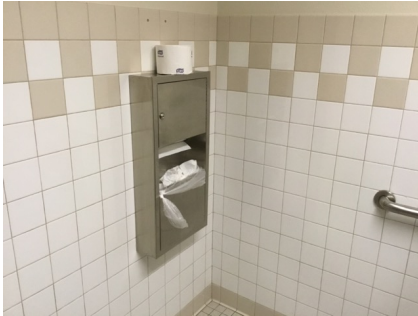
25D

Accessibility Element: Protruding Objects

Specific Item: Protruding Object

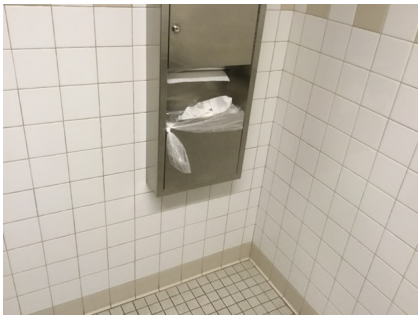
25F

Accessibility Element: Toilet and Bathing Rooms

Specific Item: Accessories

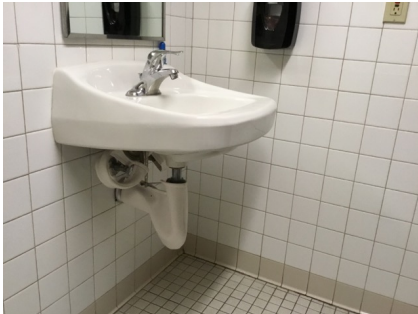
25G

Accessibility Element: Lavatories and Sinks

Specific Item: Knee Clearance

Provide new accessible lavatory with the top rim between 28" and 34" above the floor, and a knee clearance that is a min. 29" above the floor at the front edge, extends under for a min. 8" deep at min. 27" above the floor, and reduces to the toe clearance that is a min. 9" above the floor.

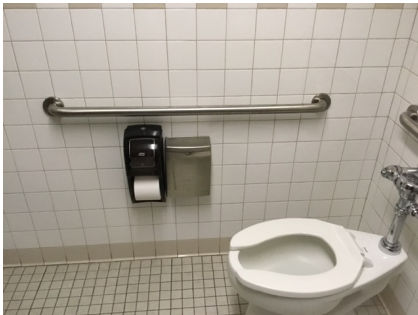
25J

Accessibility Element: Water Closets & Toilet Compartments

Specific Item: Side Grab Bar

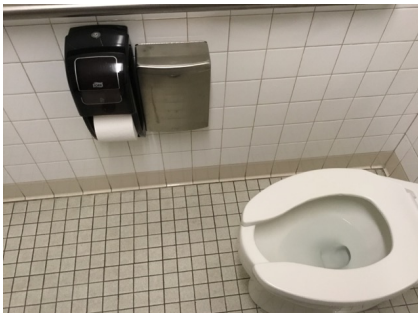
25K

Accessibility Element: Water Closets & Toilet Compartments

Specific Item: Toilet Paper Dispenser

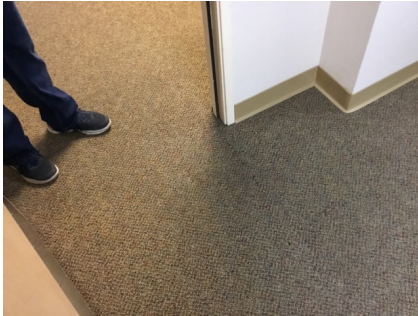
26D

Accessibility Element: Doors

Specific Item: Door Threshold

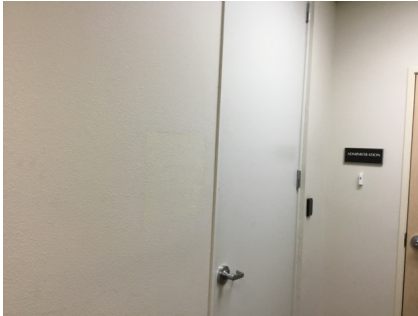
37B

Specific Item: Stairway Identification Sign

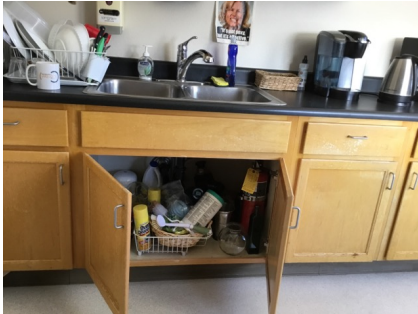
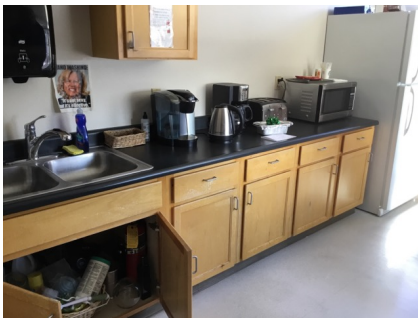
41C

Specific Item: Height & Knee Clearance

Barrier Description:
Sink rim or counter surface exceeds 34" in height and/or does not provide complying knee and toe clearance for forward approach (Exception: A kitchen sink in a space where no cook top is provided may allow for parallel approach).

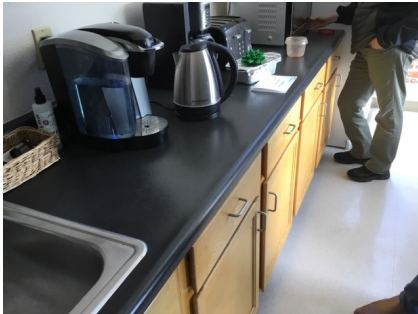
41G

Specific Item: Counter - Parallel Approach

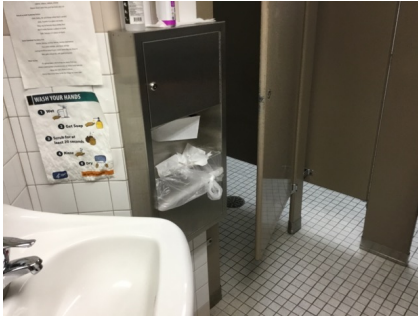
42G

Specific Item: Protruding Object

The location of an accessory/dispenser creates a protruding hazard that protrudes more than 4" into the circulation path between 27" and 80" from the ground.

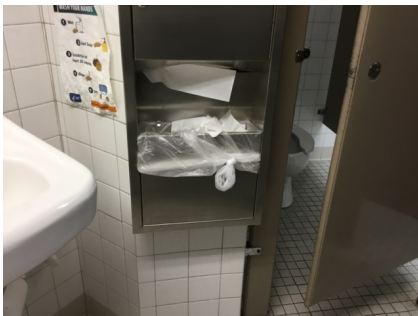
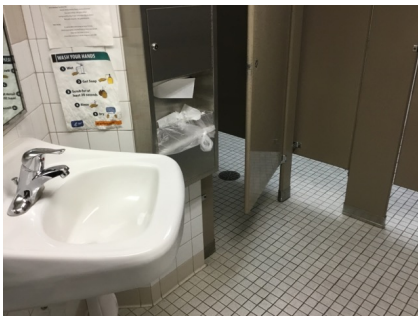
42H

Specific Item: Accessories

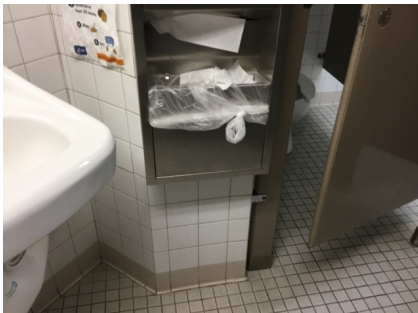
42I

Specific Item: Accessories

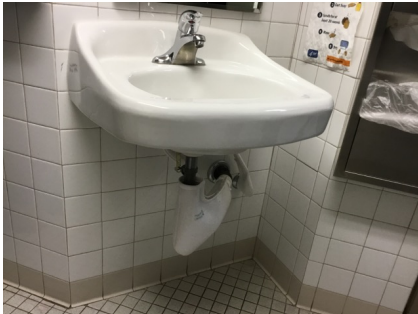
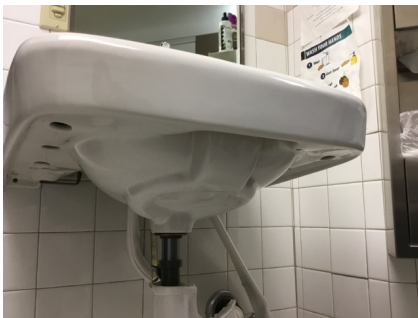
42J

Specific Item: Knee Clearance

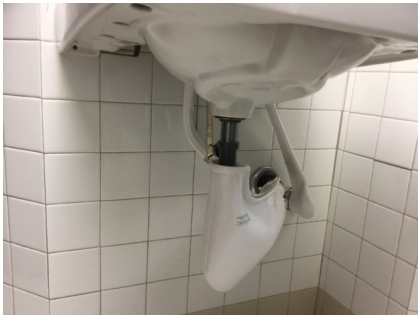
42K

Specific Item: Exposed Pipes and Surfaces

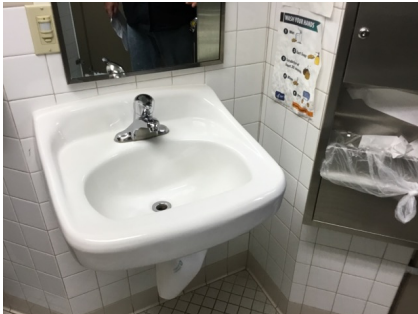
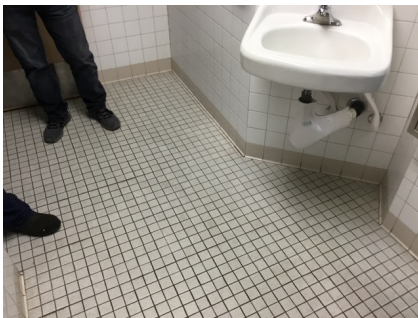
42L

Specific Item: Centerline

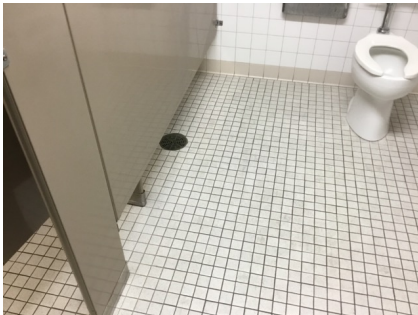
42O

Specific Item: Clearance

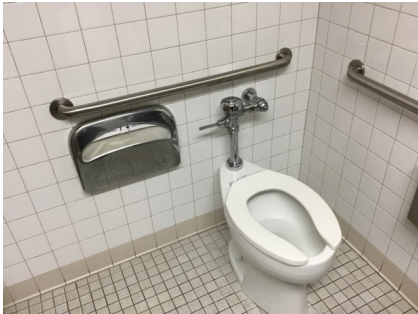
42P

Specific Item: Rear Grab Bar

Remount water closet to between 17"-18" o.c. and match grab bar centerline to provide provide a min. 12" and 24".

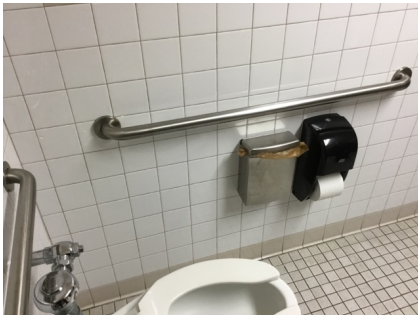
42Q

Specific Item: Side Grab Bar

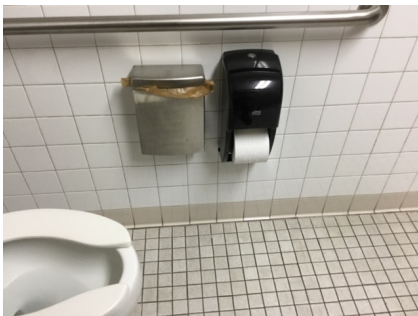
42R

Specific Item: Toilet Paper Dispenser

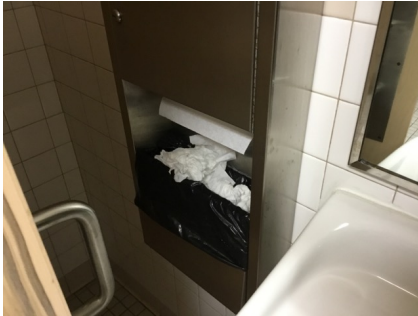
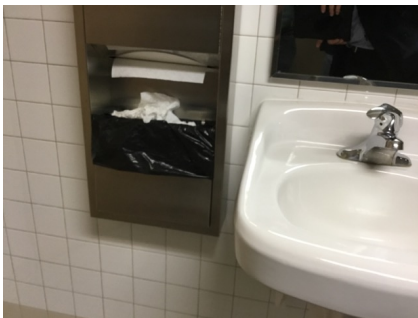
43H

Specific Item: Accessories

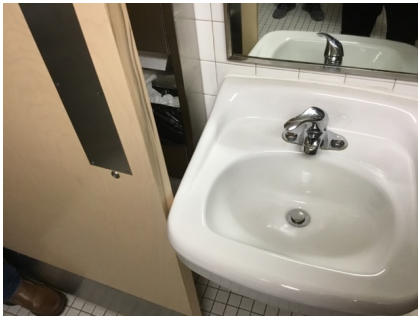
43I

Specific Item: Maneuvering Clearance

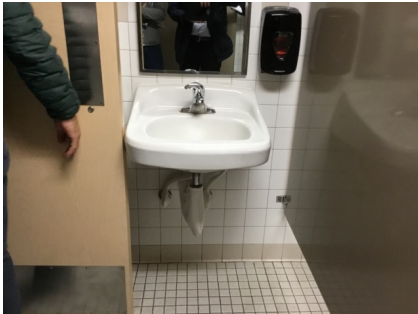
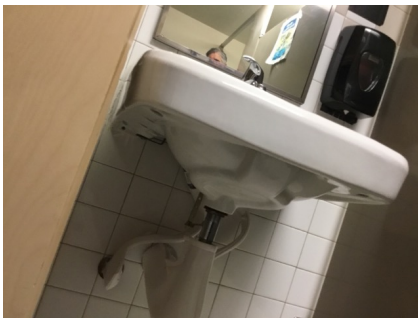
43J

Specific Item: Knee Clearance

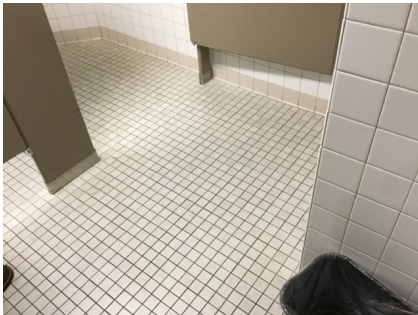
43M

Specific Item: Maneuvering Clearance

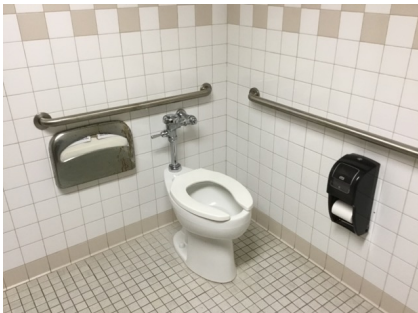
43N

Specific Item: Rear Grab Bar

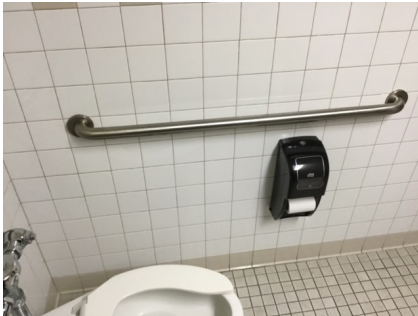
43O

Specific Item: Side Grab Bar

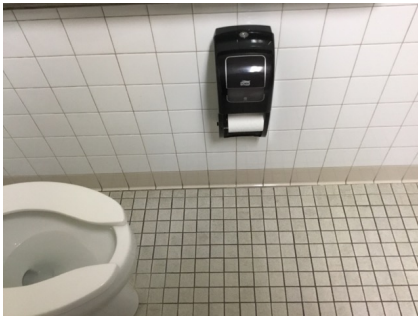
43P

Specific Item: Toilet Paper Dispenser

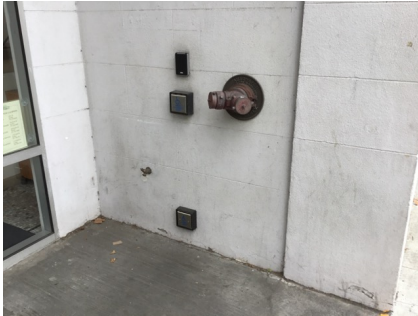
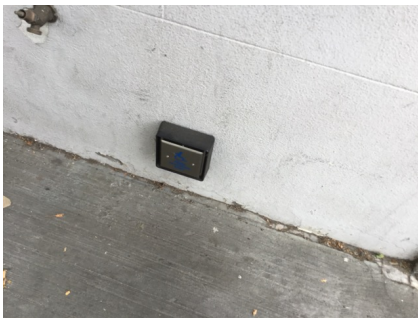
1E

Specific Item: Push Plates

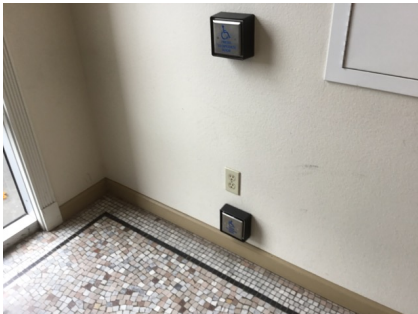
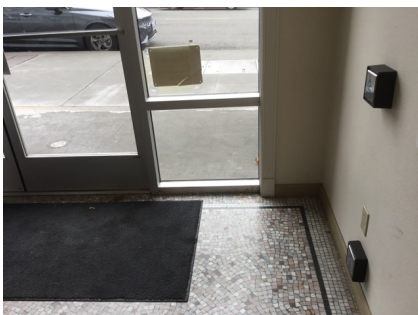
1F

Specific Item: Push Plates

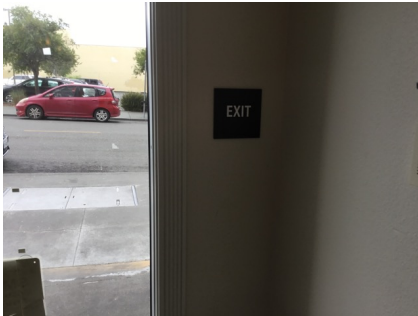
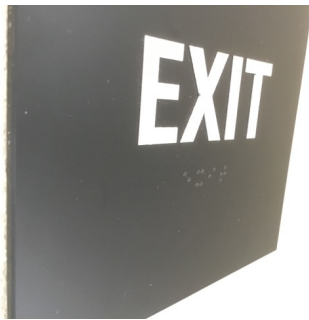
11

Specific Item: Installation

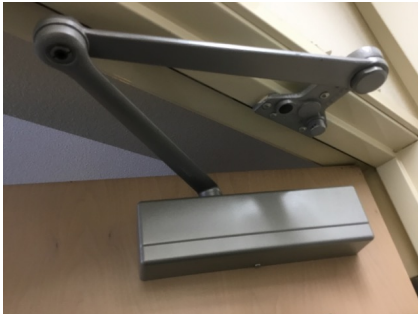
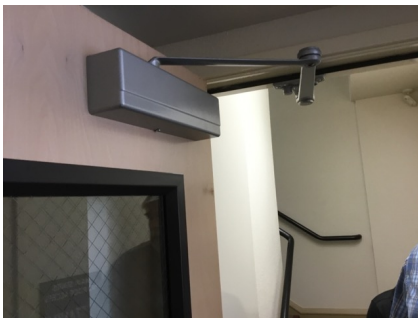
6C

Specific Item: Door Pressure

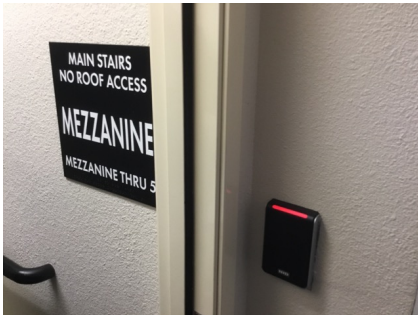
6E

Specific Item: Floor Identification Sign

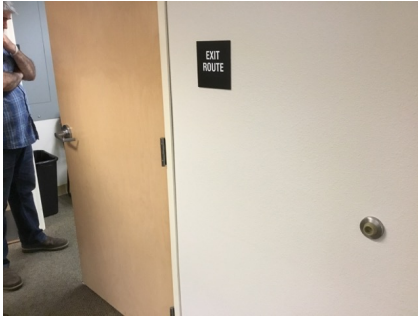
12G

Accessibility Element: Signs

Specific Item: Installation

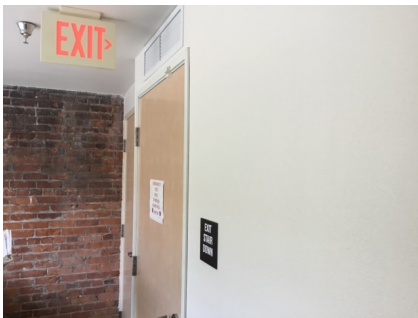
SZS 13C
Mezzanine – Exit Stairway
OPEN

CBC 2019: 11B-404.2.8

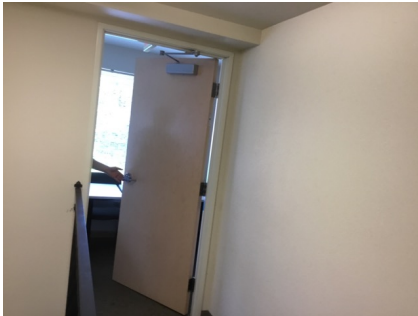
13D

Accessibility Element: Stairways

Specific Item: Stairway Identification Sign

CBC 2019: 11B-504.8

Provide compliant stairway identification sign on the latch side of doors within the enclosed stairway.

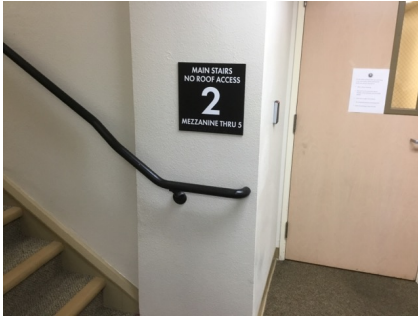
16A

Accessibility Element: Stairways

Specific Item: Stairway Identification Sign

CBC 2019: 11B-504.8

Relocate to accessible location.

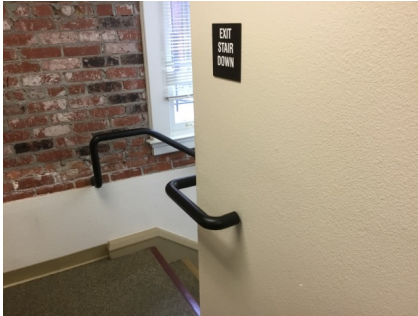
17A

Accessibility Element: Signs

Specific Item: Installation

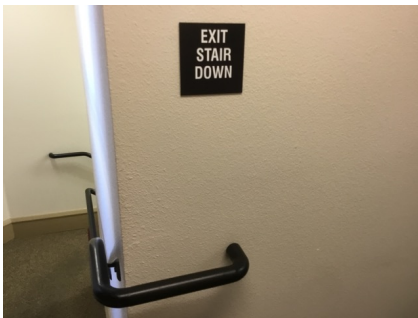
Second Floor – Corridor 200C

OPEN

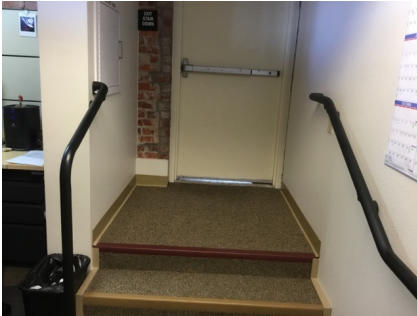
22A

Accessibility Element: Signs

Specific Item: Installation

CBC 2019: 11B-703.4.2

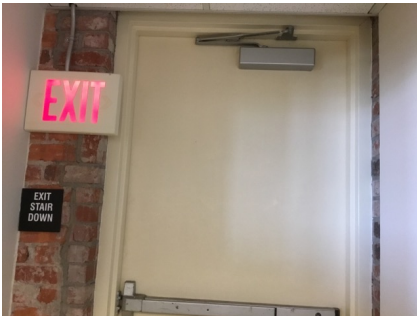
22C

Accessibility Element: Doors

Specific Item: Door Pressure

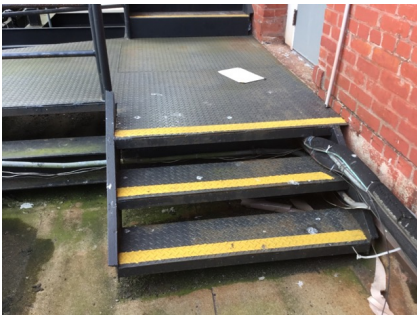
22D

Accessibility Element: Stairways

Specific Item: Contrasting Stripe

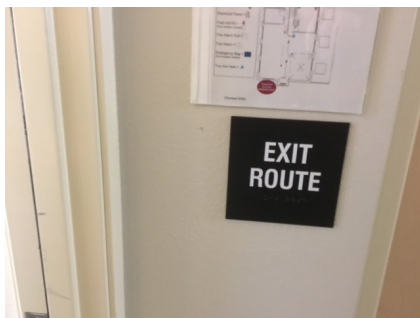
Second Floor – Exit Corridor to Elevator Lobby

OPEN

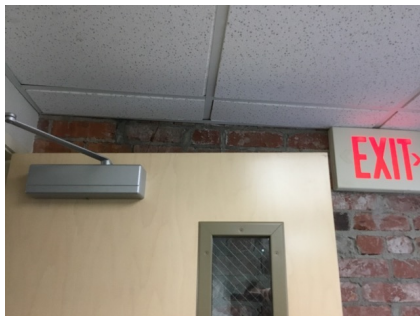
23F

Accessibility Element: Doors

Specific Item: Door Pressure

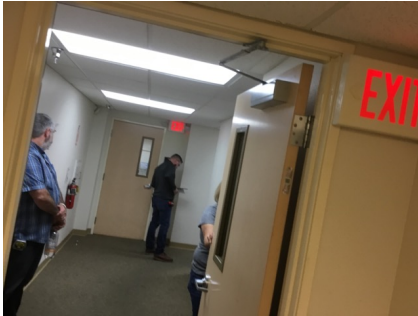
26B

Accessibility Element: Doors

Specific Item: Door Pressure

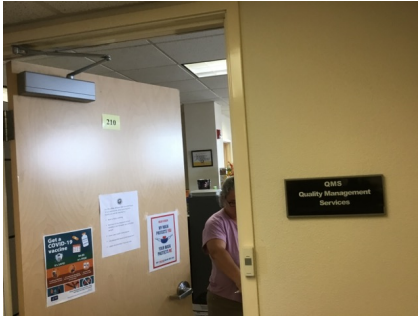
27D

Accessibility Element: Doors

Specific Item: Door Pressure

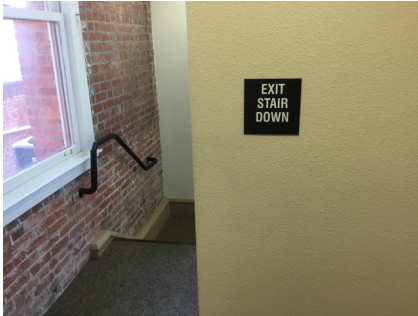
31A

Accessibility Element: Signs

Specific Item: Exit Signage

CBC 2019: 1013.4

Relocate to accessible location.

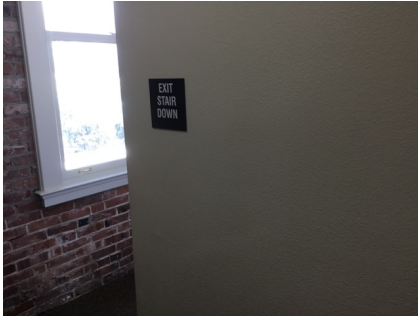
37A

Accessibility Element: Signs

Specific Item: Exit Signage

CBC 2019: 1013.4

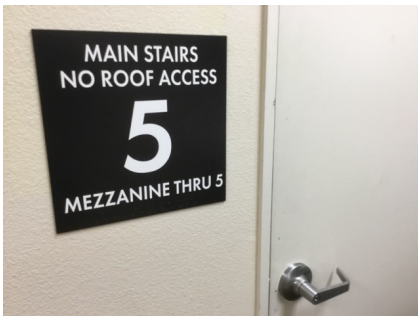
Fifth Floor – Stairway

CLOSED

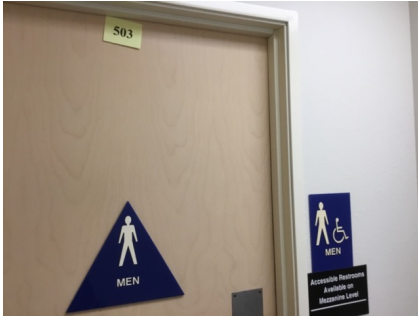
43D

Accessibility Element: Doors

Specific Item: Door Pressure

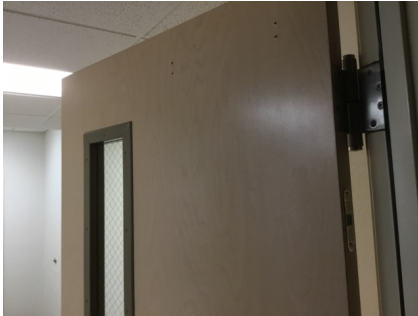
44C

Accessibility Element: Doors

Specific Item: Door Pressure

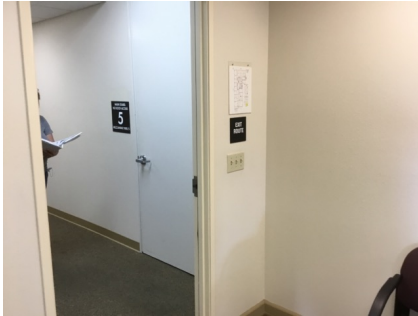
46F

Accessibility Element: Signs

Specific Item: Exit Signage

CBC 2019: 1013.4

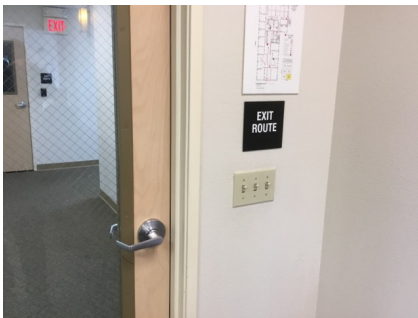
Fifth Floor – Room 512

CLOSED

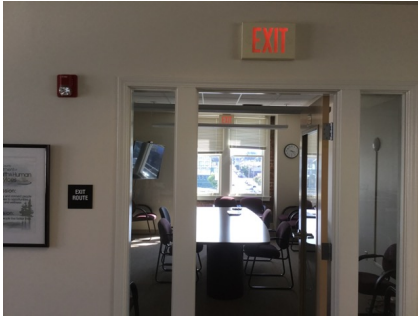
47B

Accessibility Element: Signs

Specific Item: Exit Signage

CBC 2019: 1013.4

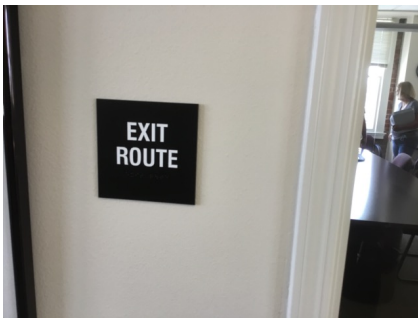
Fifth Floor – Conference Room 514

CLOSED
