ATTACHMENT 1b  
Sprowl Creek Full Resubmittal

# ETA Humboldt, LLC

**Photographs Correlating to Site Management Plan Map**

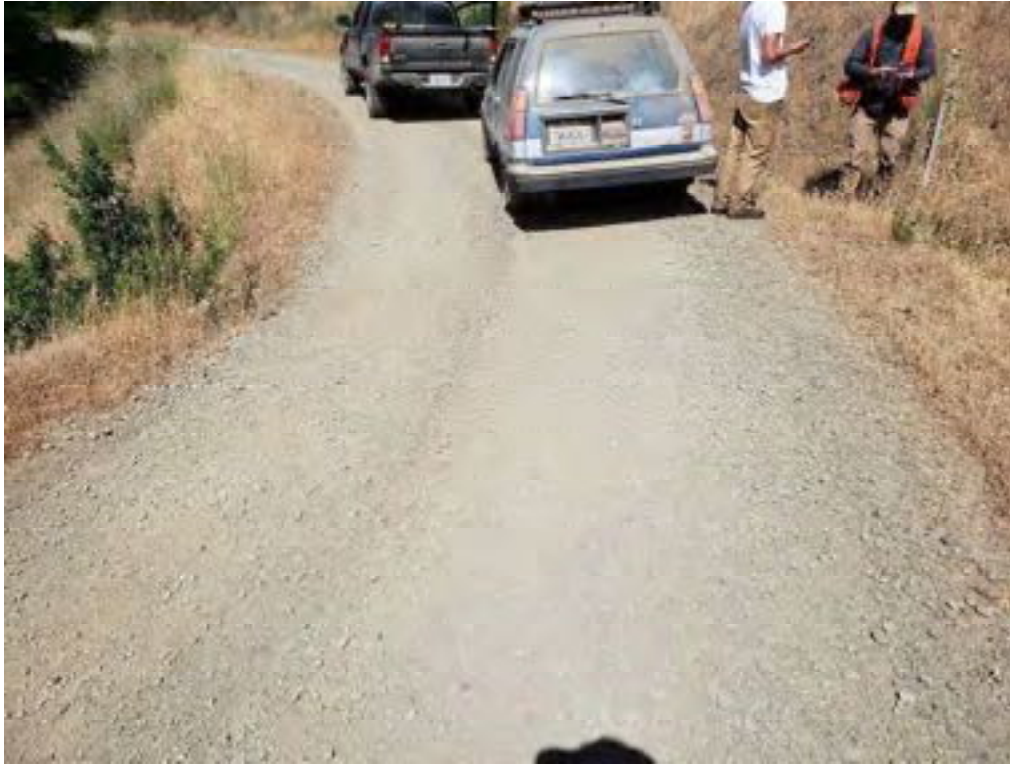
*Site 03. Looking west.*

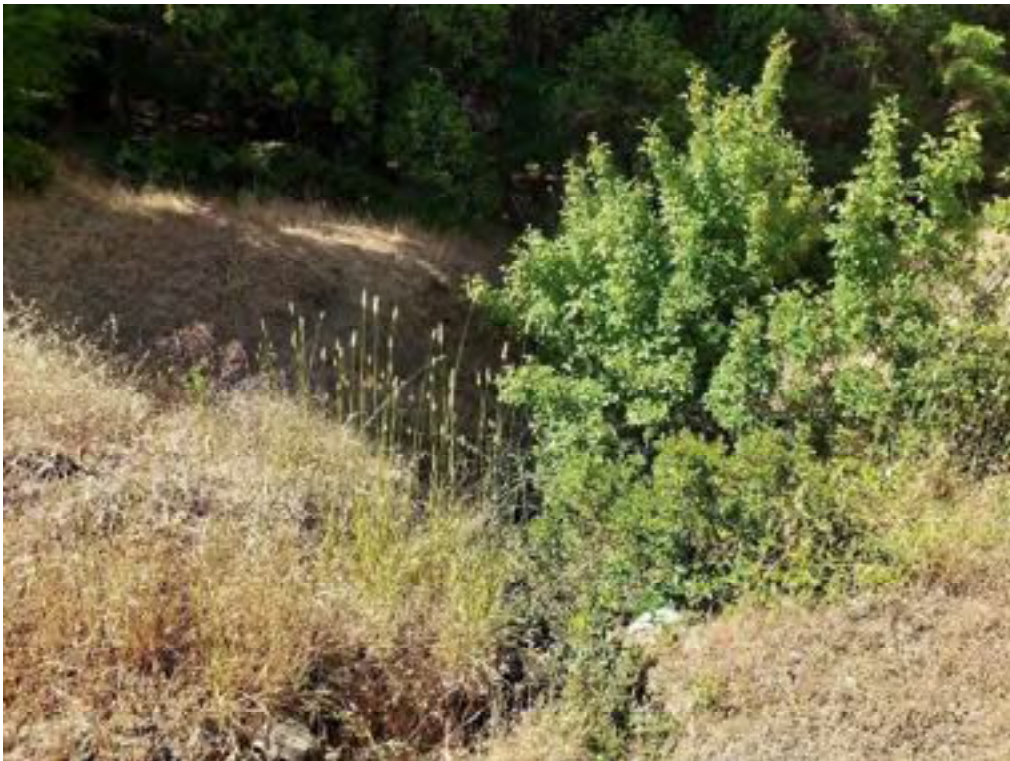
*Site 03. Looking down channel from the outlet.*

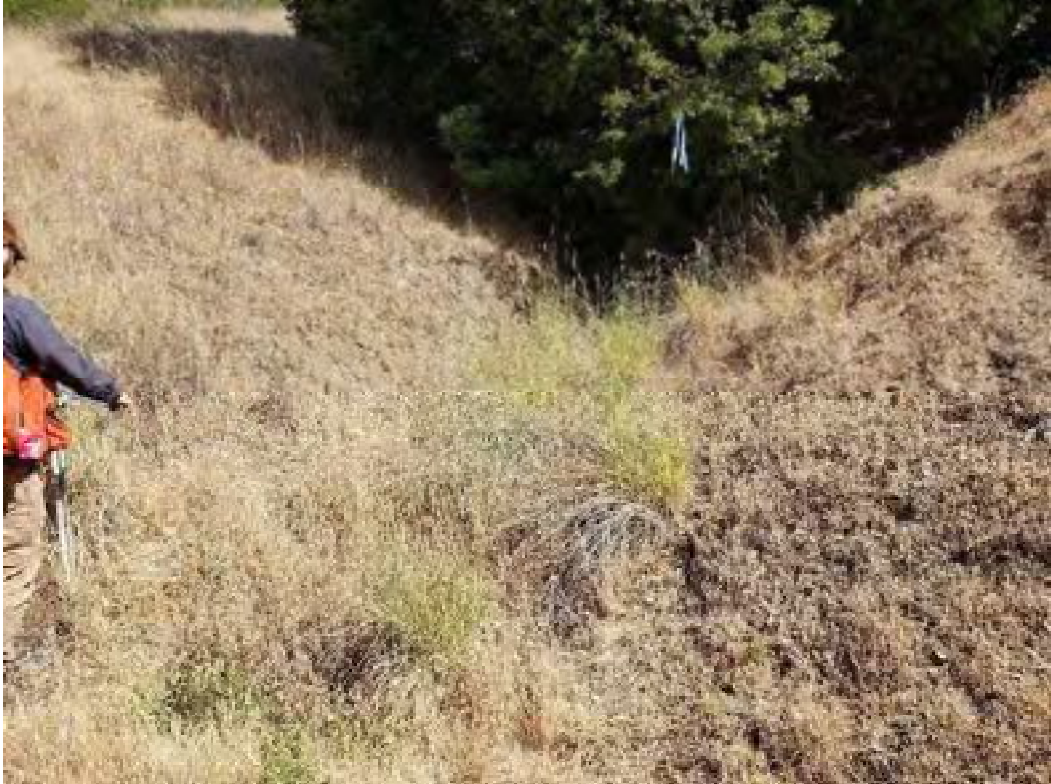
Site 03. Looking up channel from the inlet.

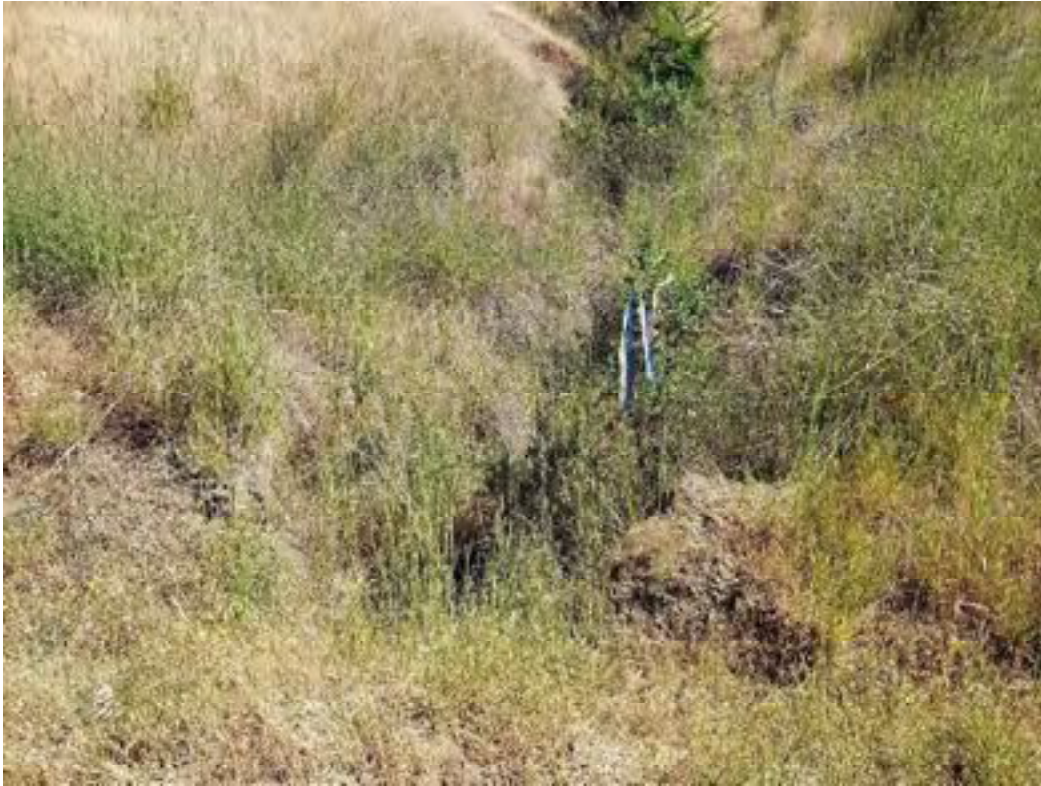
*Site 04. Looking up channel from the inlet.*

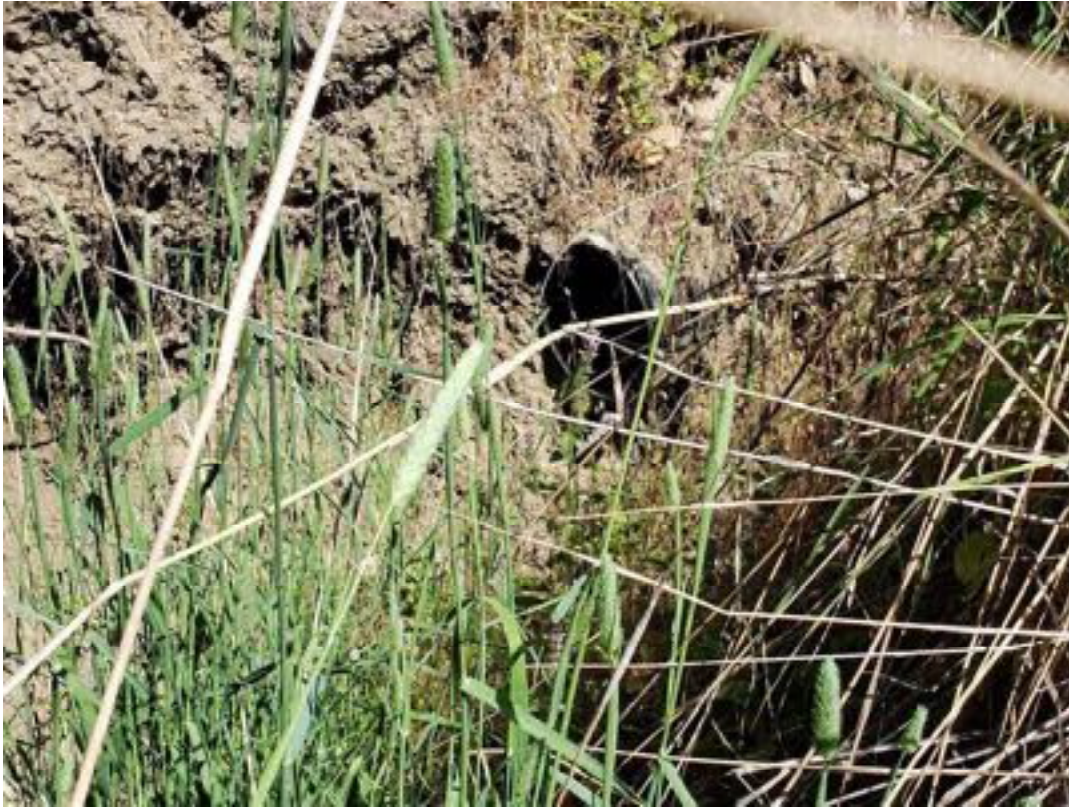
Site 04. Looking at the outlet.

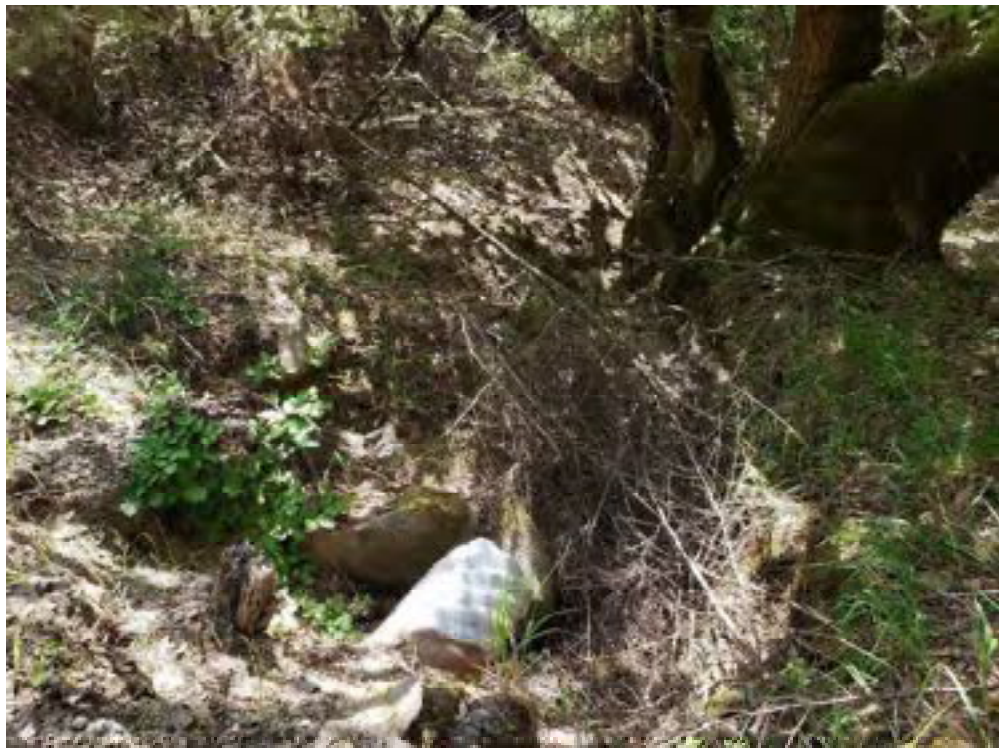
*Site 05. Looking down channel from the outlet.*

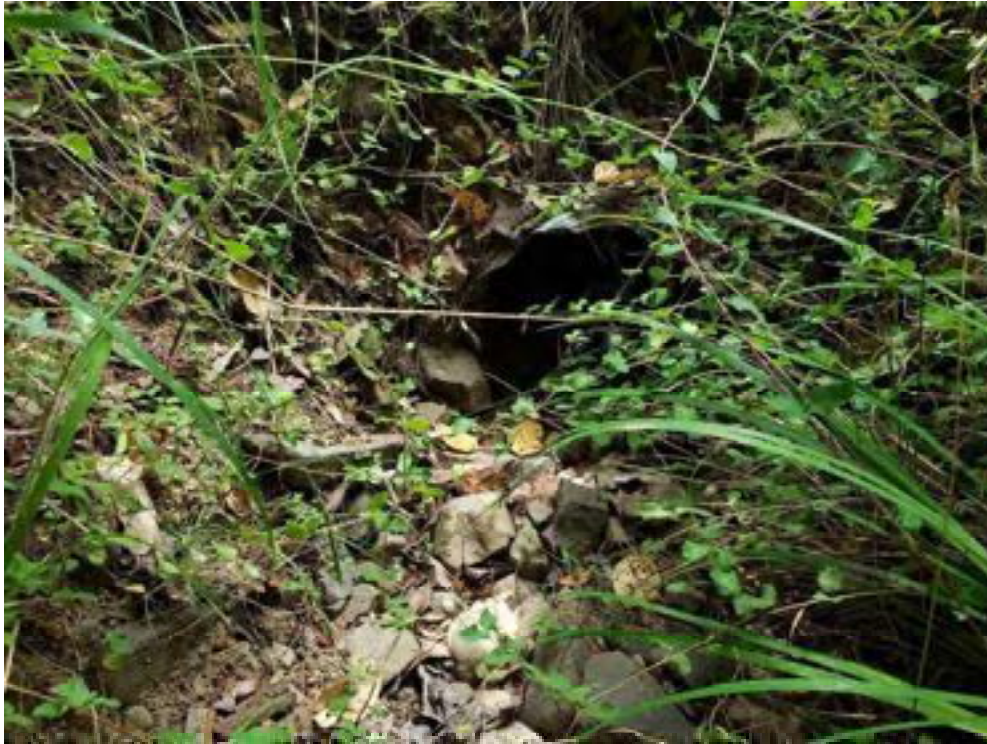
*Site 06. Looking at the inlet.*

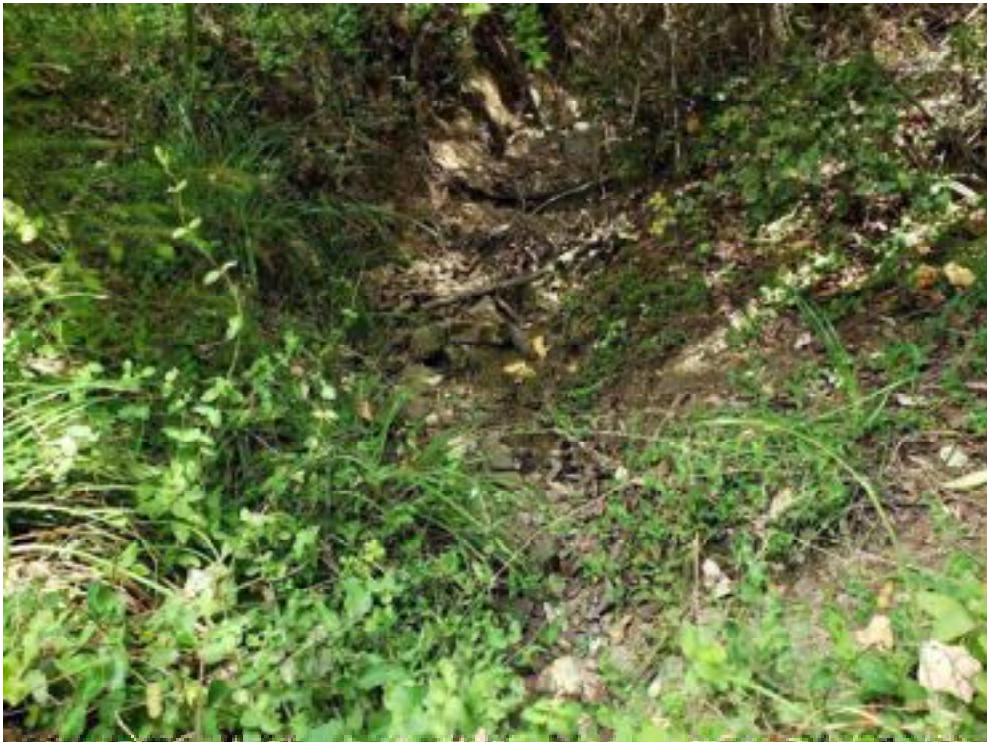
*Site 06. Looking up channel from the inlet.*

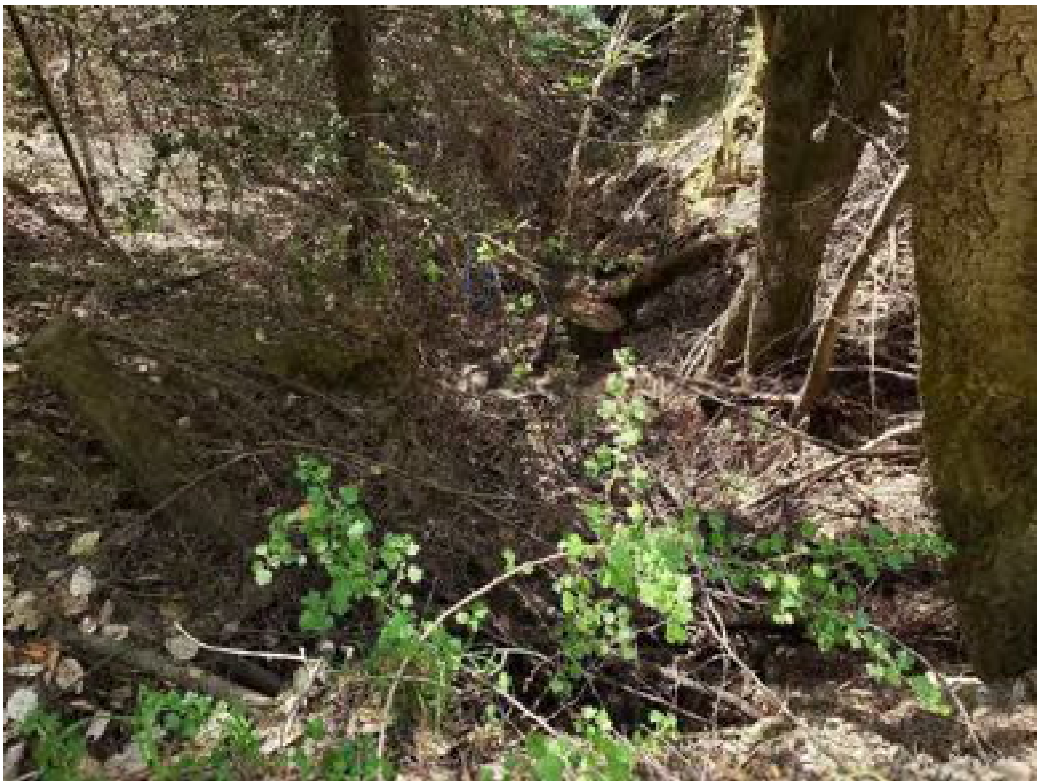
Site 06. Looking down channel from the outlet. The upgraded culvert will outlet approximately where the blue flagging is hanging.

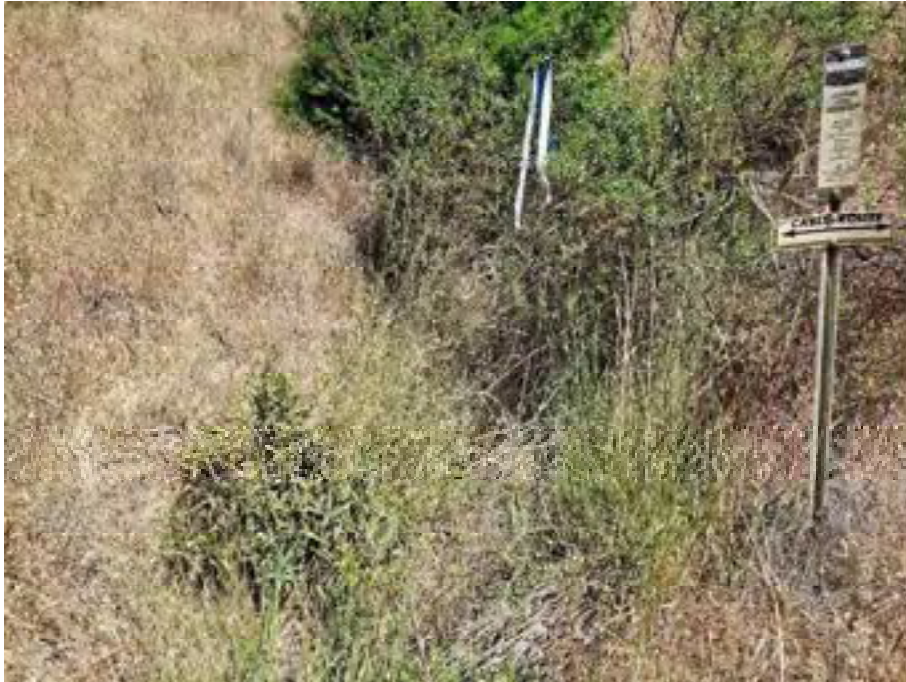
*Site 07. Looking up channel from the inlet.*

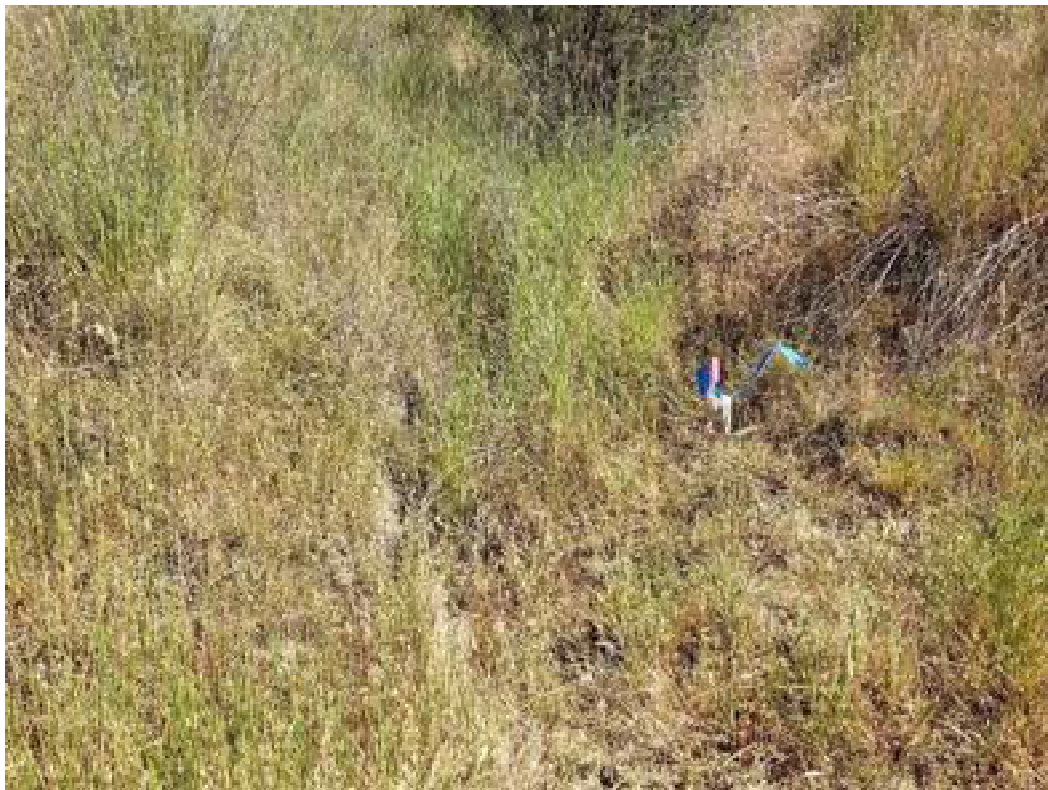
*Site 08. Looking up channel from the inlet of the culvert.*

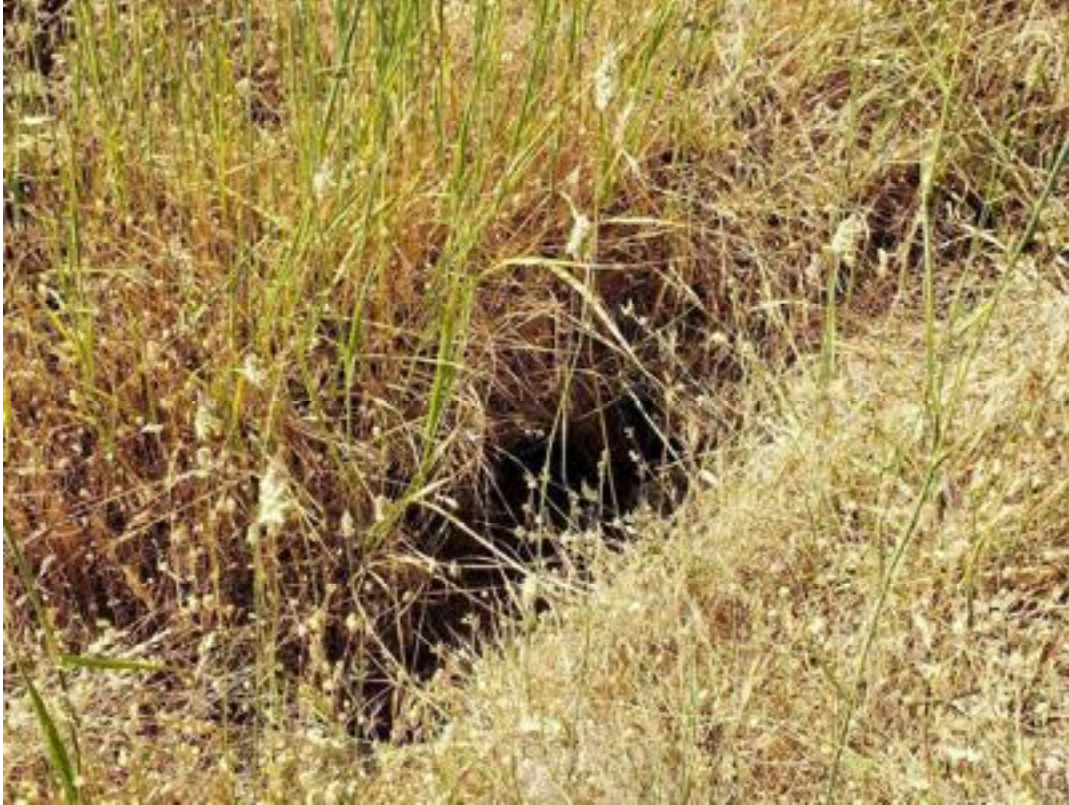
*Site 08. Looking at the inlet.*

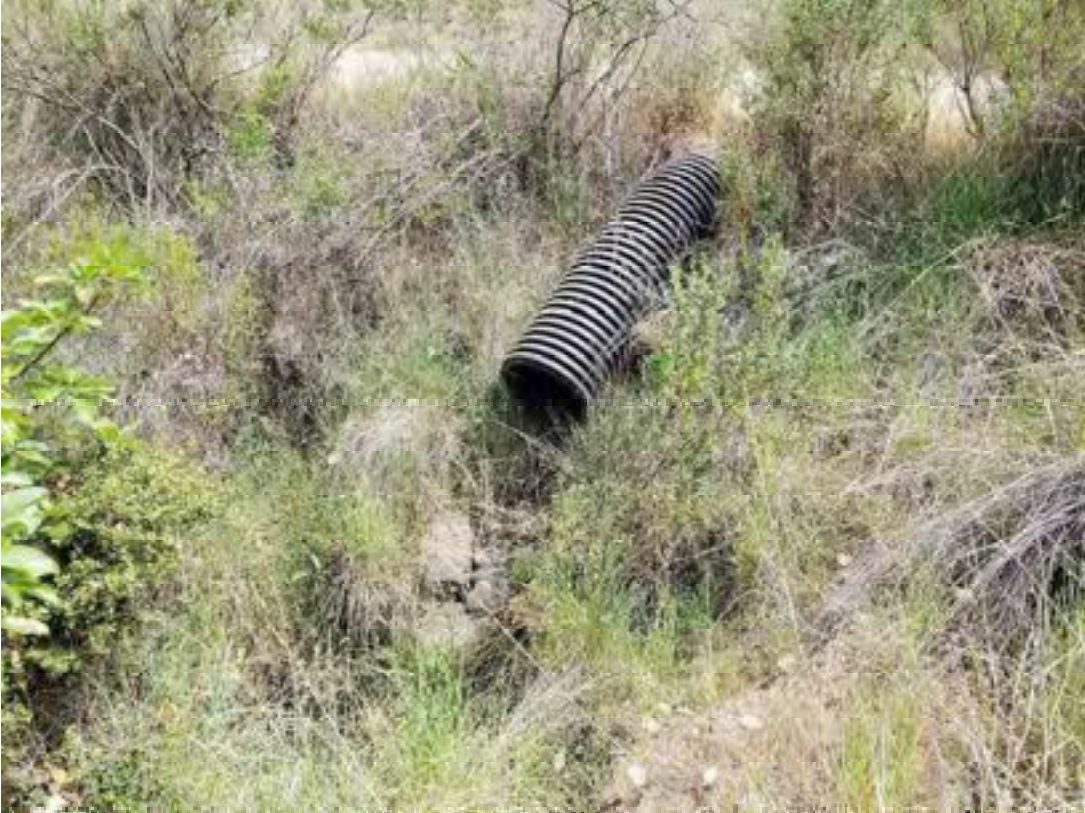
Site 11. Looking at the outlet of the culvert.

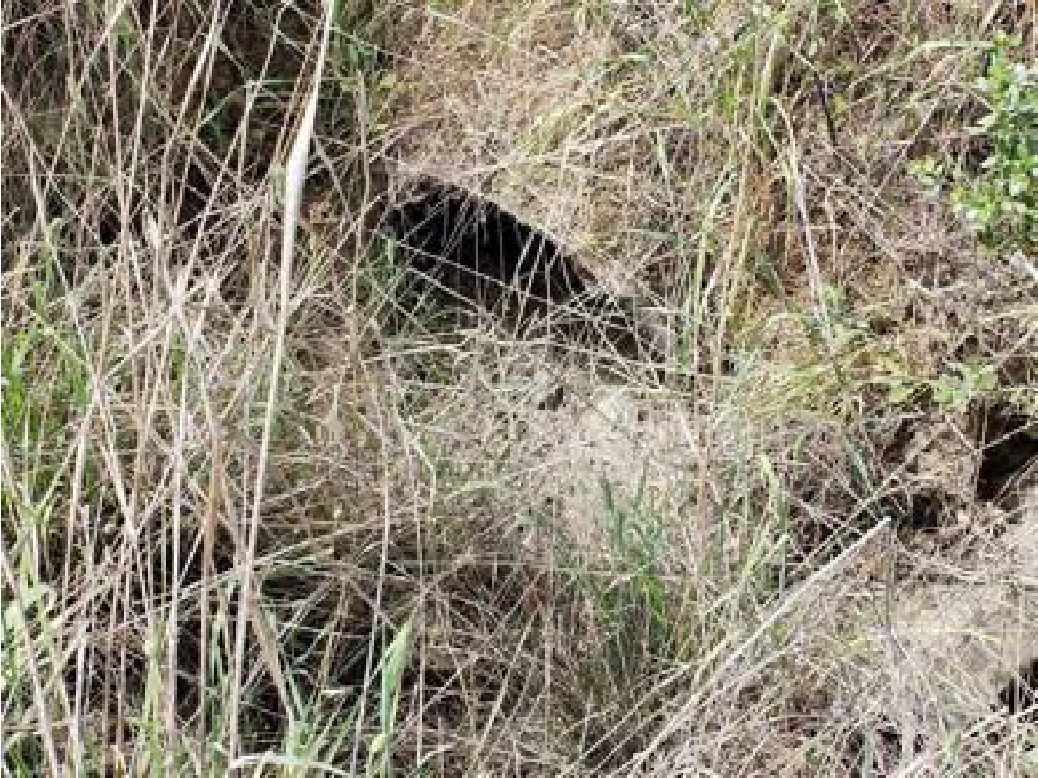
Site 11. Looking at the inlet.

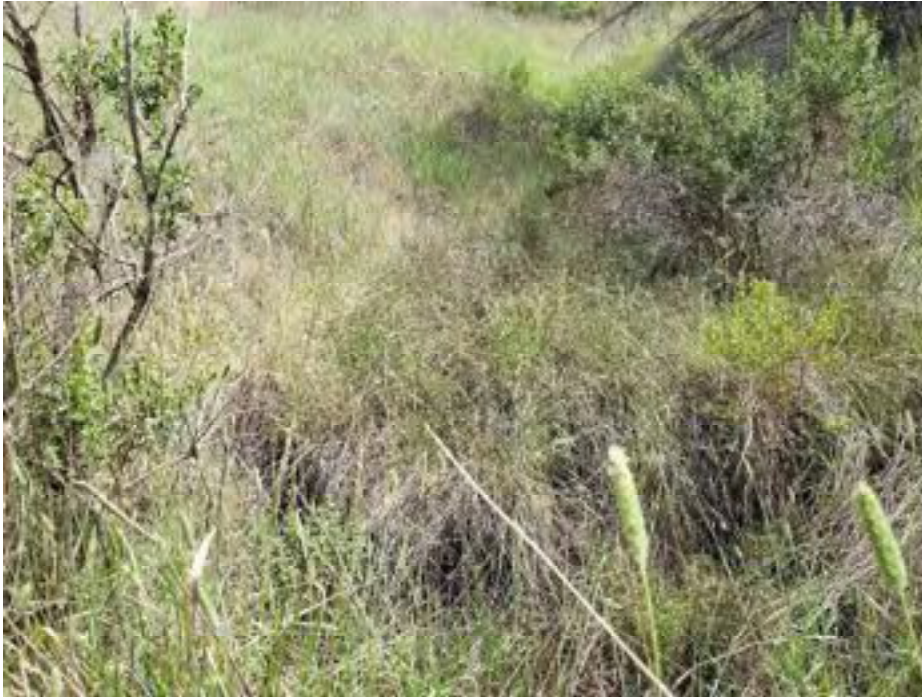
Site 11. Looking up channel from the inlet.

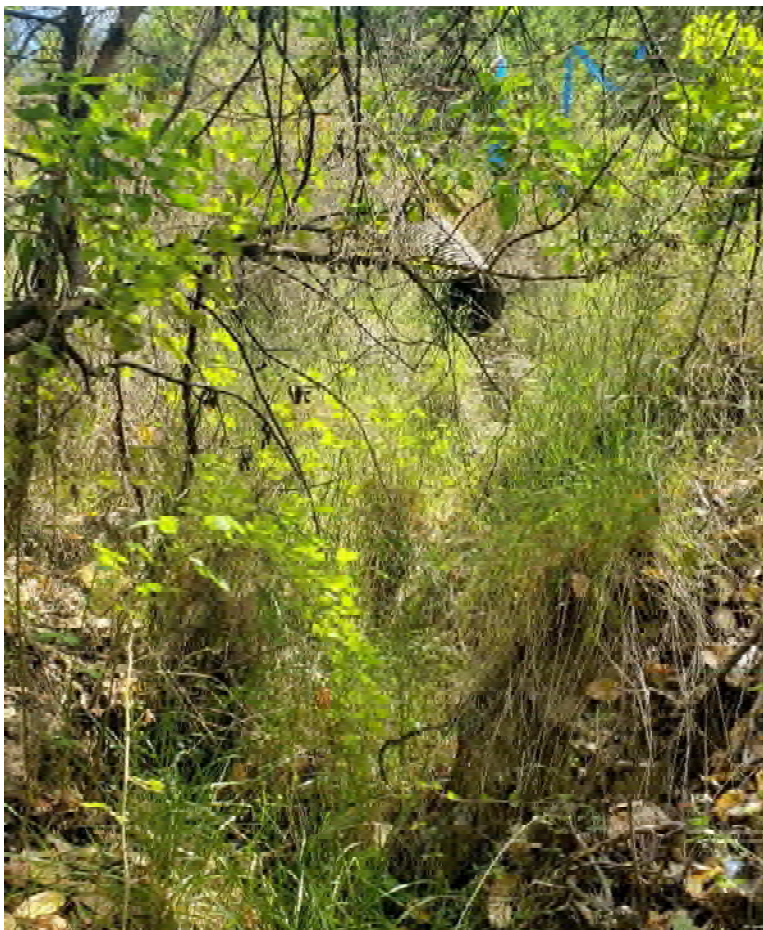
Photo looking at where the proposed outlet of the watercourse crossing at Site 11 will be approximately.

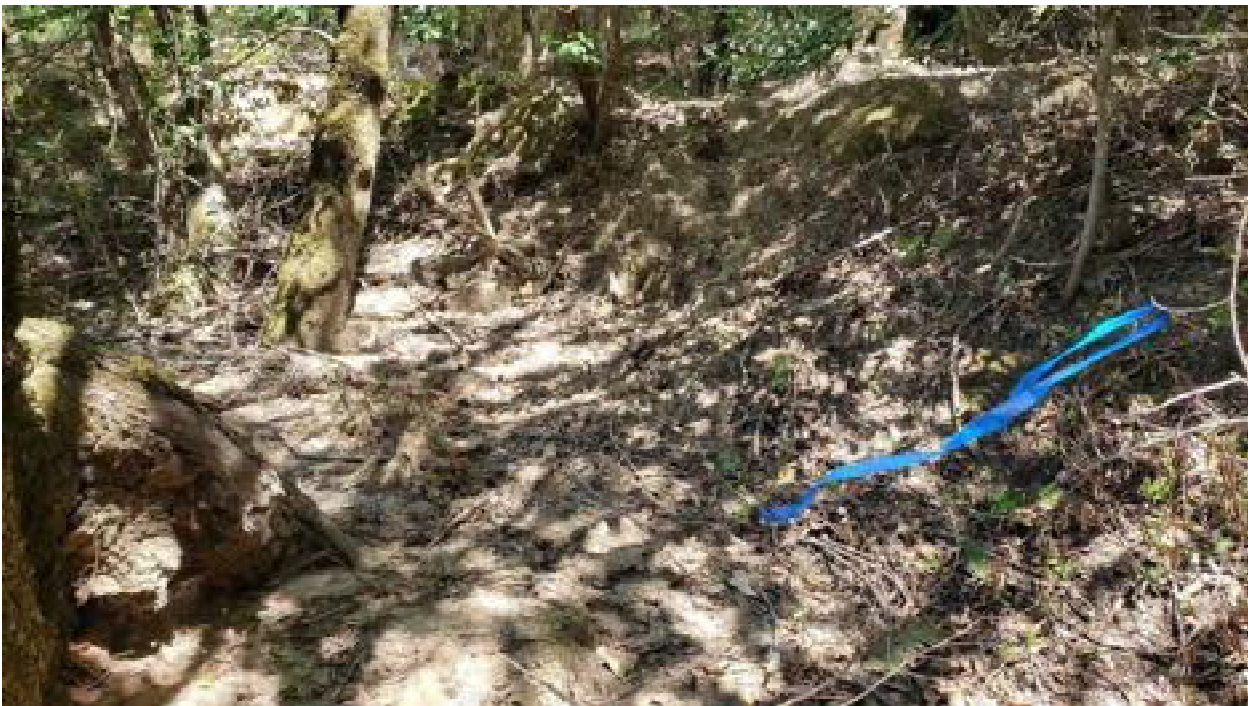
Site 13. Proposed outlet location.

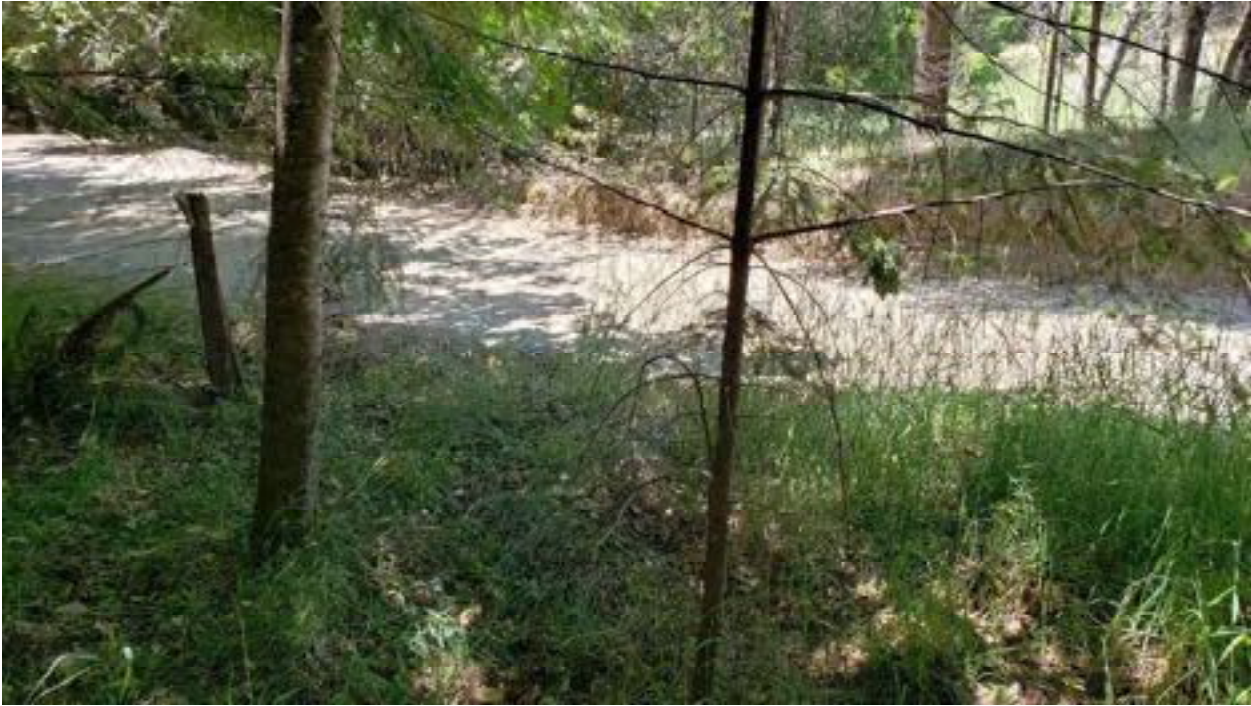
Site 13. Proposed inlet location.

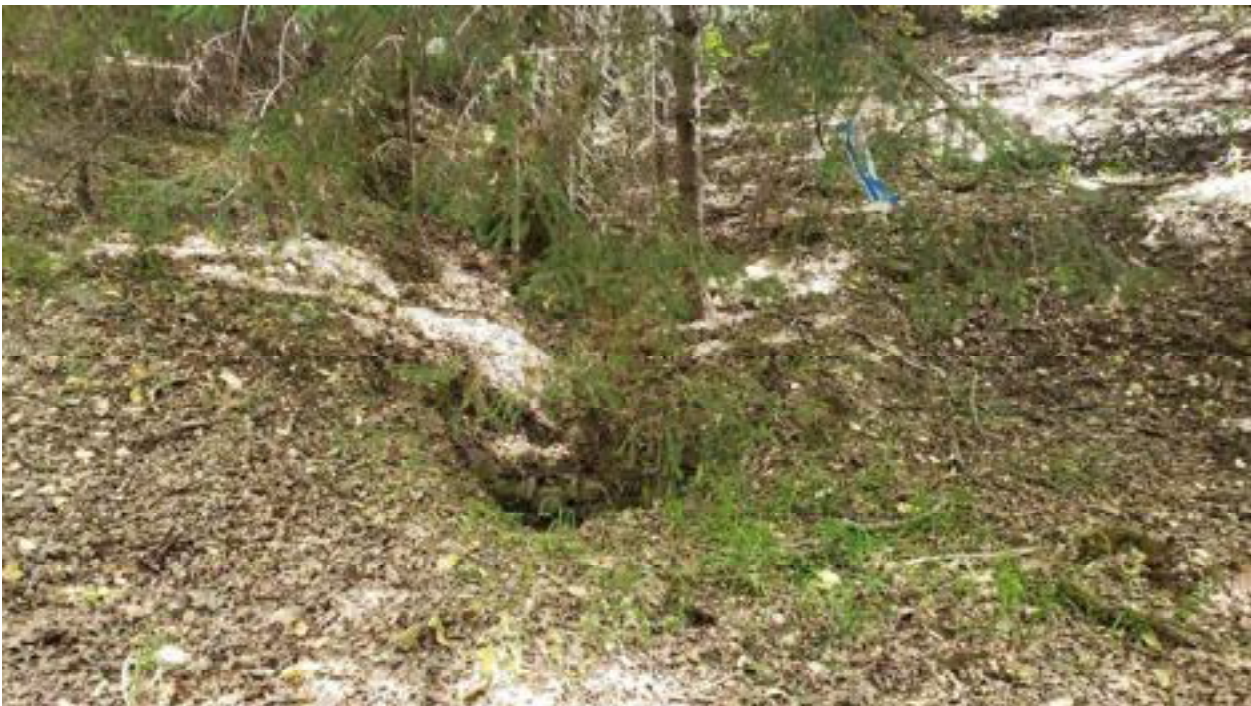
Inlet of the watercourse crossing at Site 17.

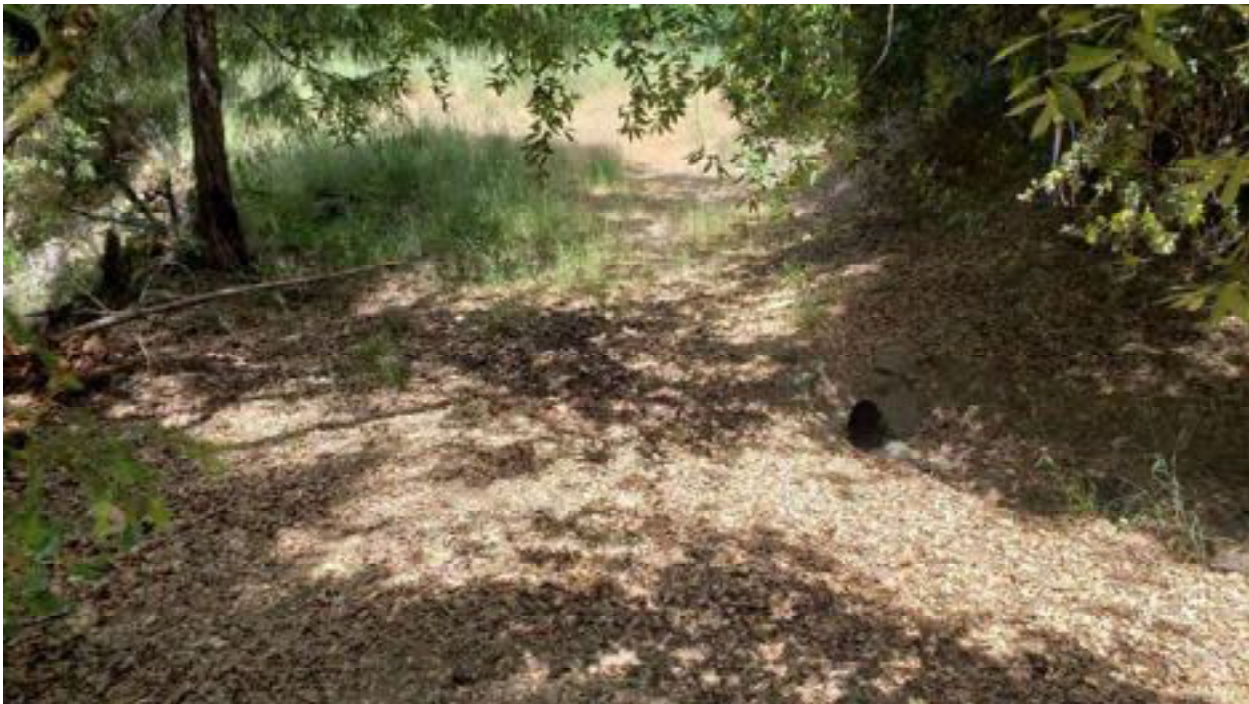
*Site 19. The watercourse crossing here will be decommissioned and will be re-aligned to its natural channel up grade approxiametly to where this photo was taken.*

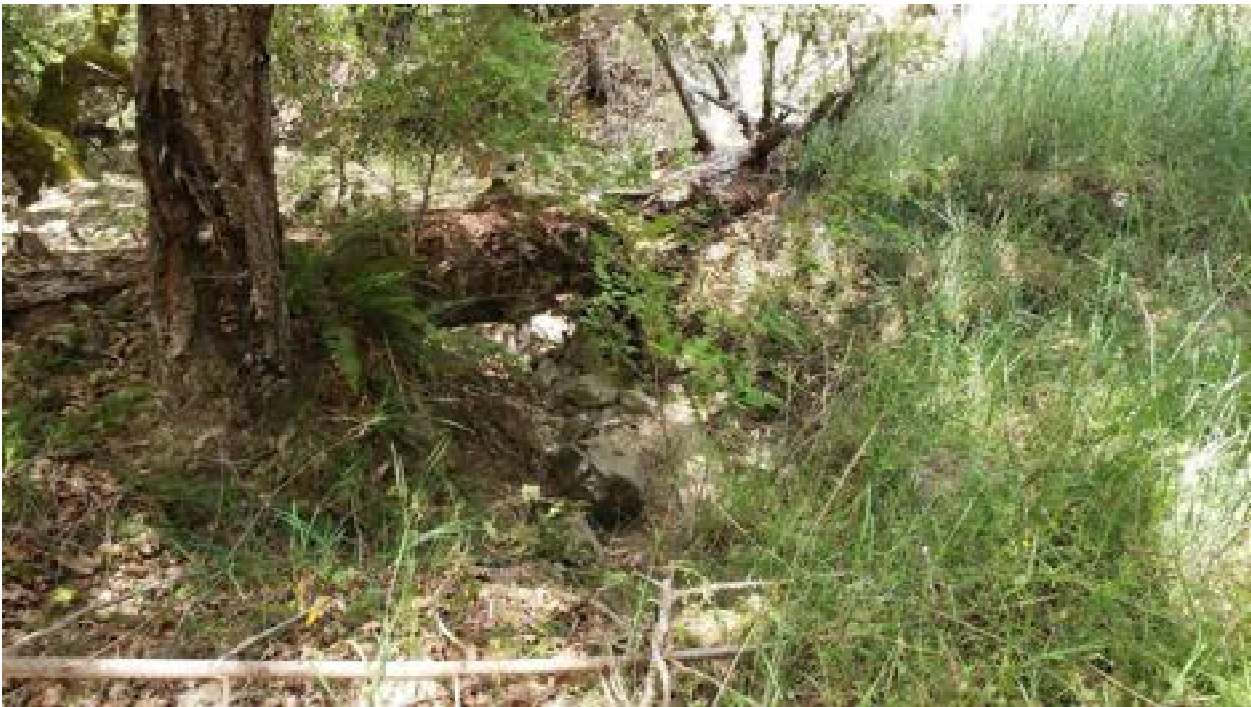
*Site 19. Looking down channel from the outlet.*

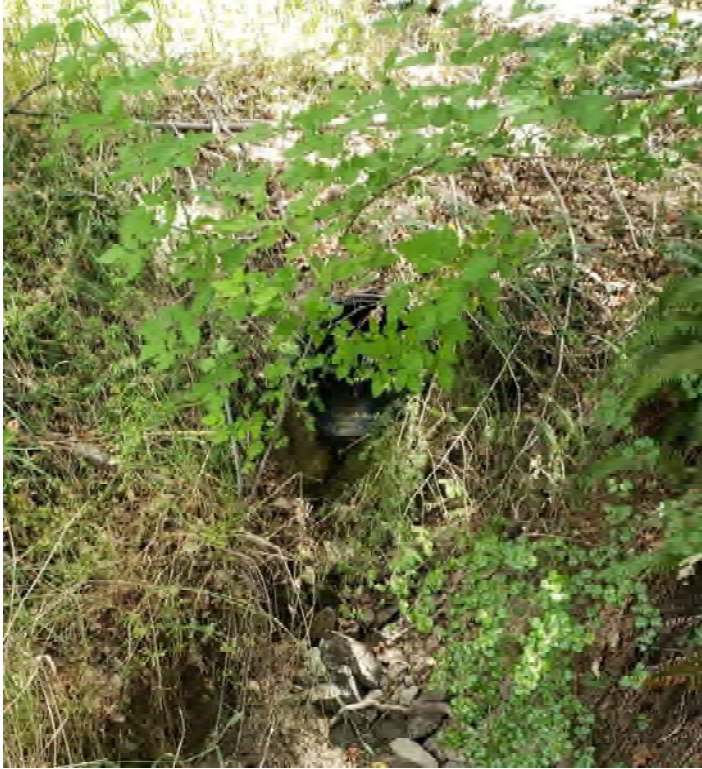
Site 19. Looking at the outlet.

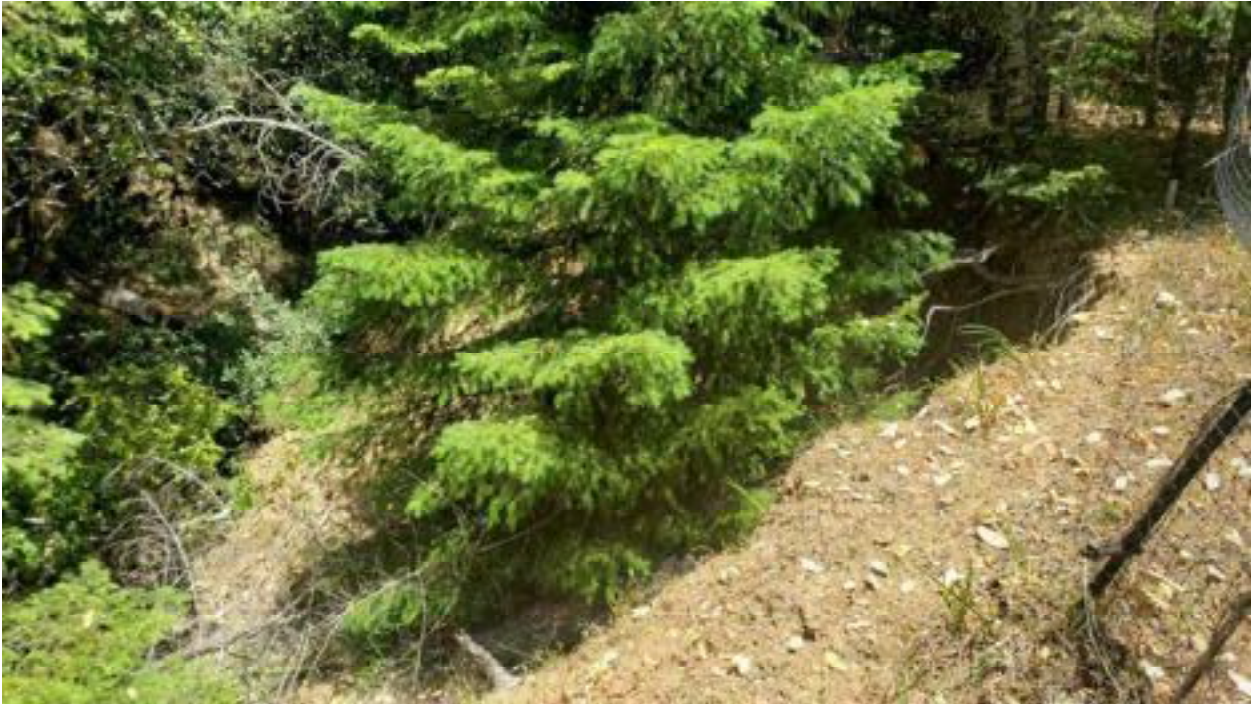
*Looking at the upper extent of Site 21.*

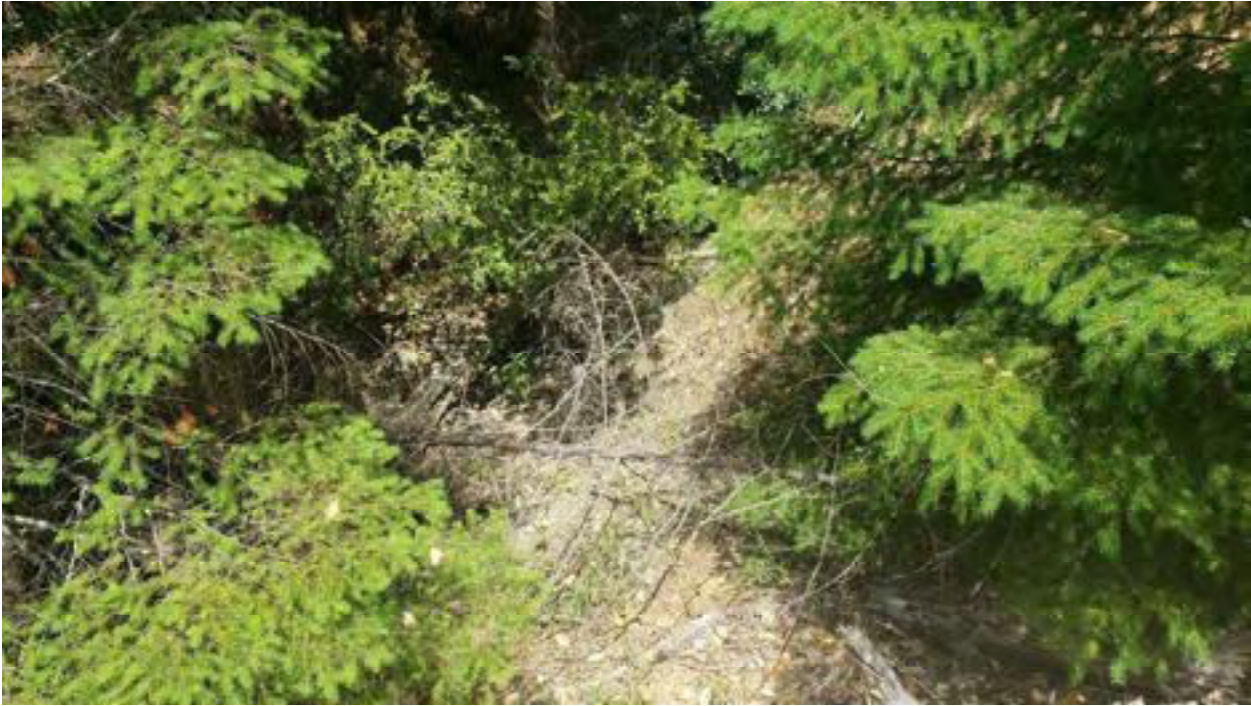
*Photo looking southwest at Site 21.*

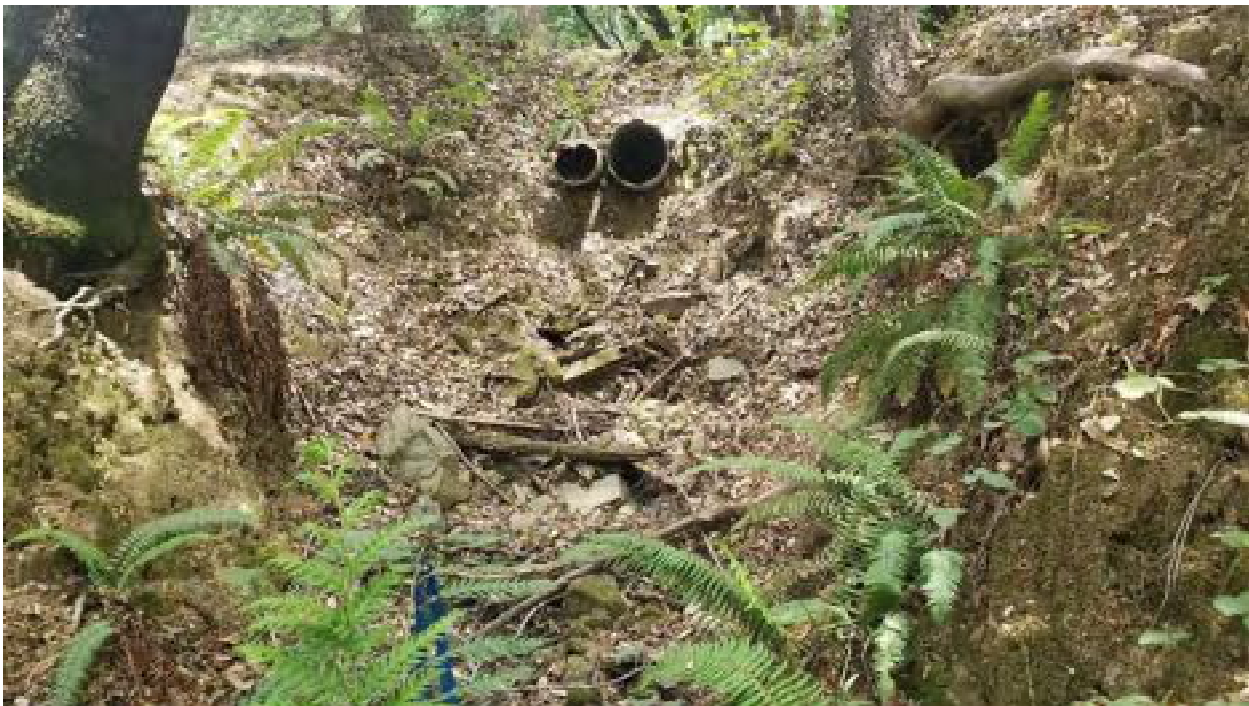
Site 23 looking up channel from the inlet. The inlet is to the right of the photo by the tree.

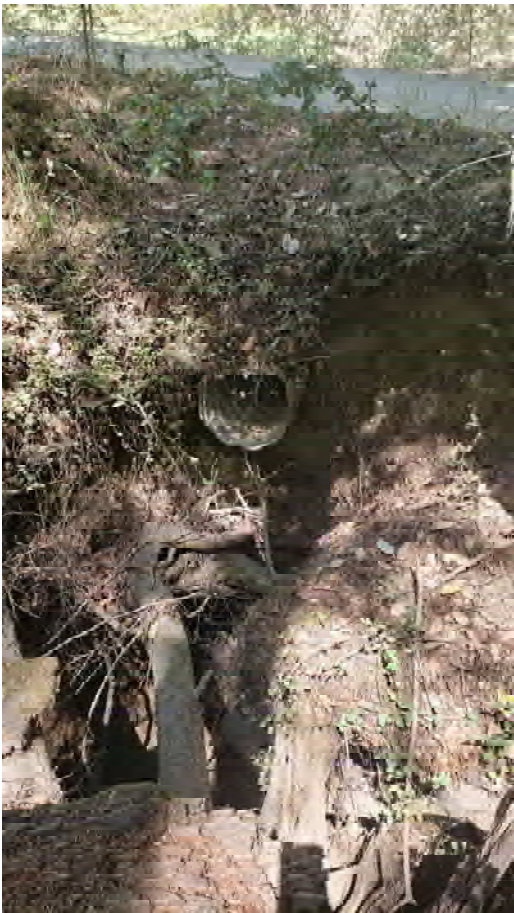
Site 24. Outlet of the watercourse crossing.

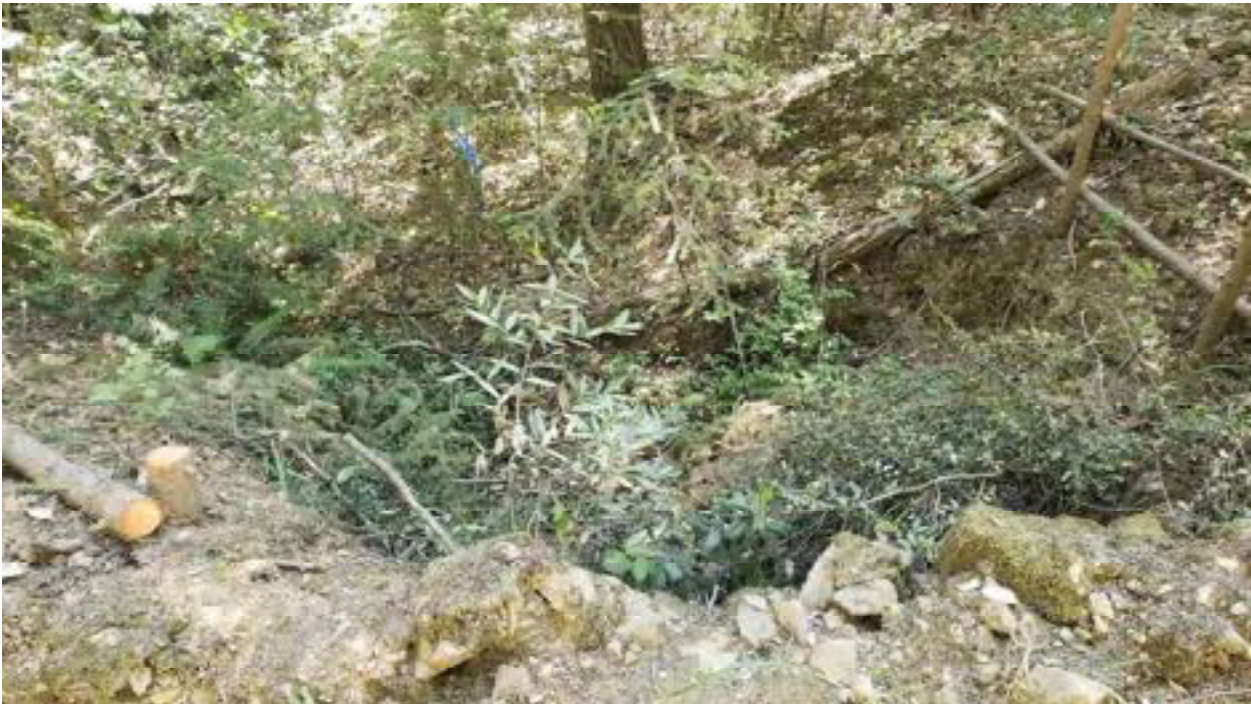
Site 26. Looking down channel from the outlet.

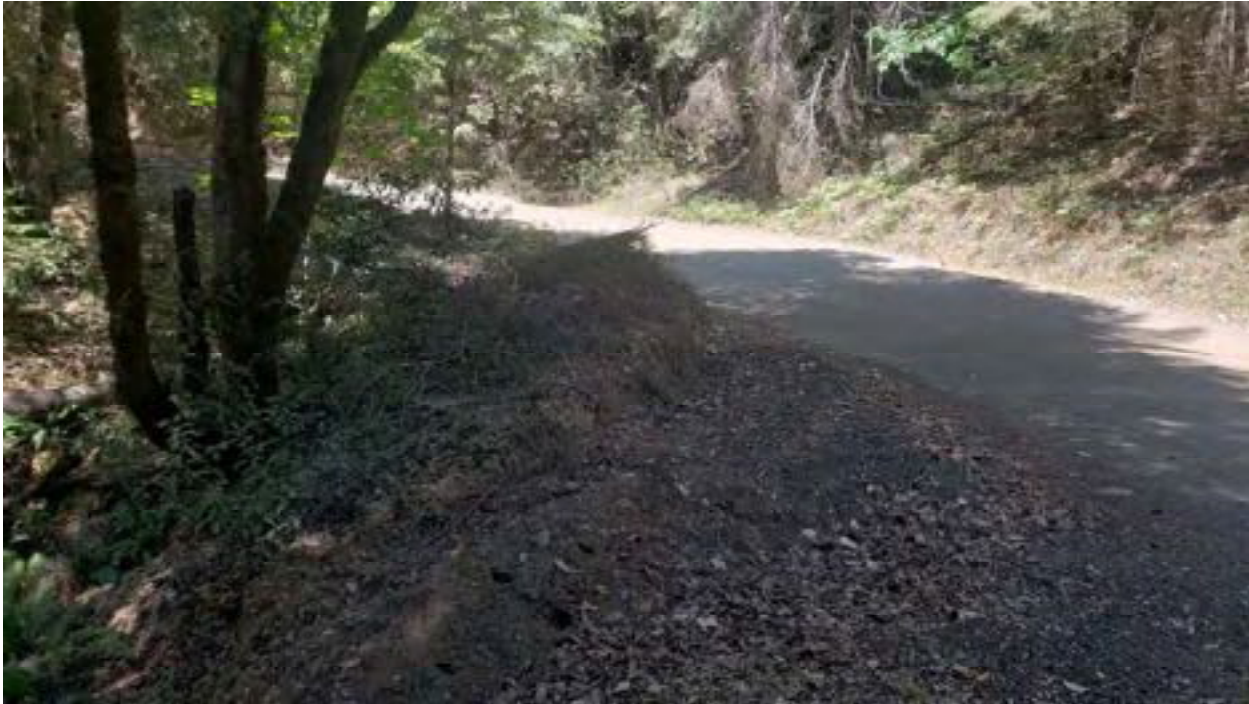
Site 27 looking up grade at Site 26.
