ATTACHMENT 1b  
Sprowl Creek Full Resubmittal

# ETA Humboldt, LLC

**Photographs Correlating to Site Management Plan Map**

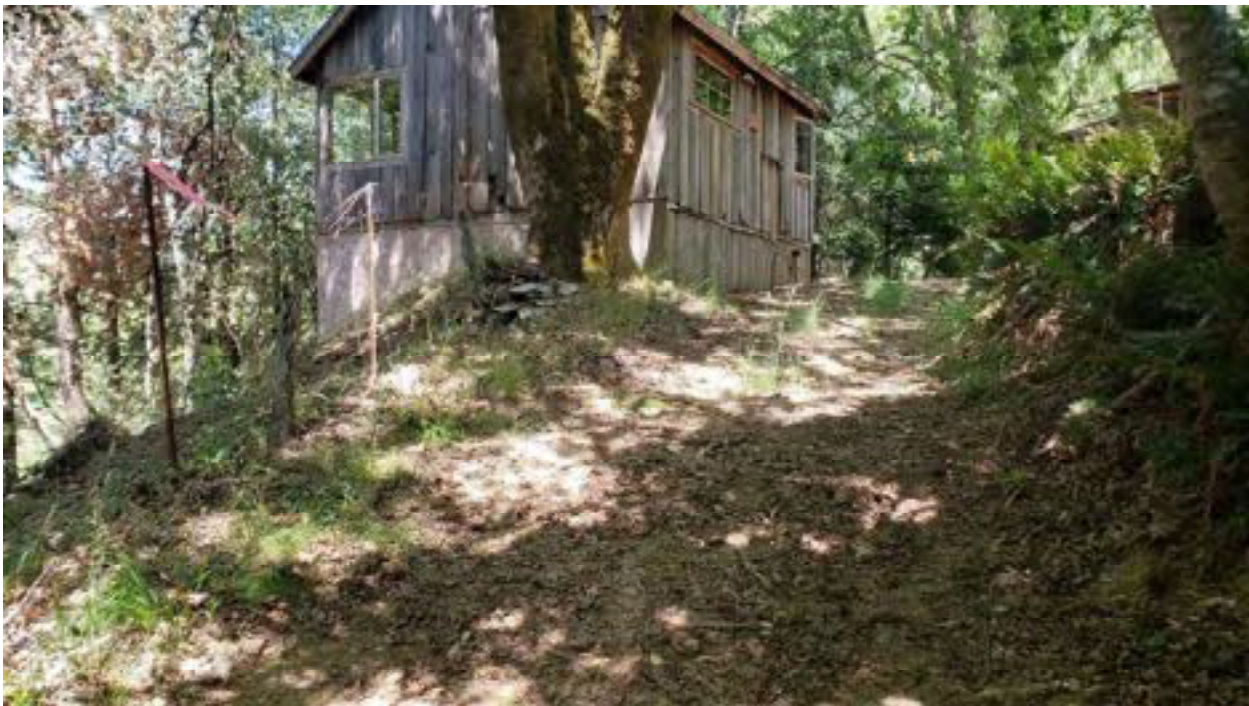
Site 34. Looking up grade at Site 34.

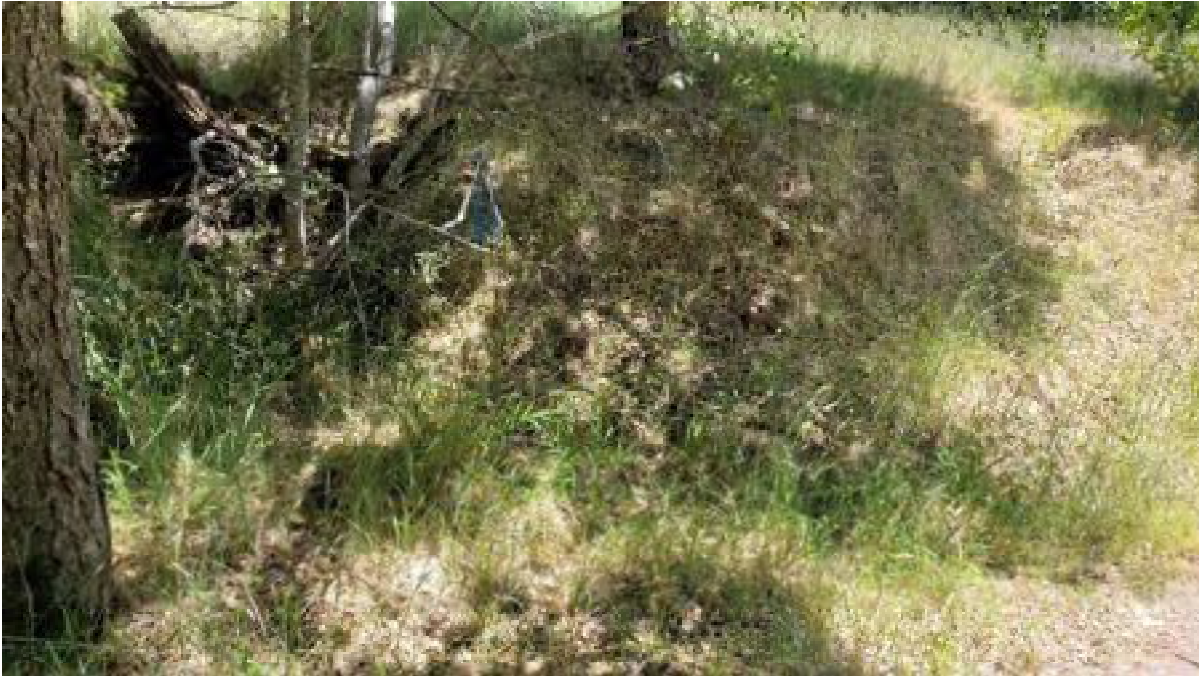
Site 35. Looking at the inlet to the lower center right and the incoming stream channel to the center left where the rotten stump is located.

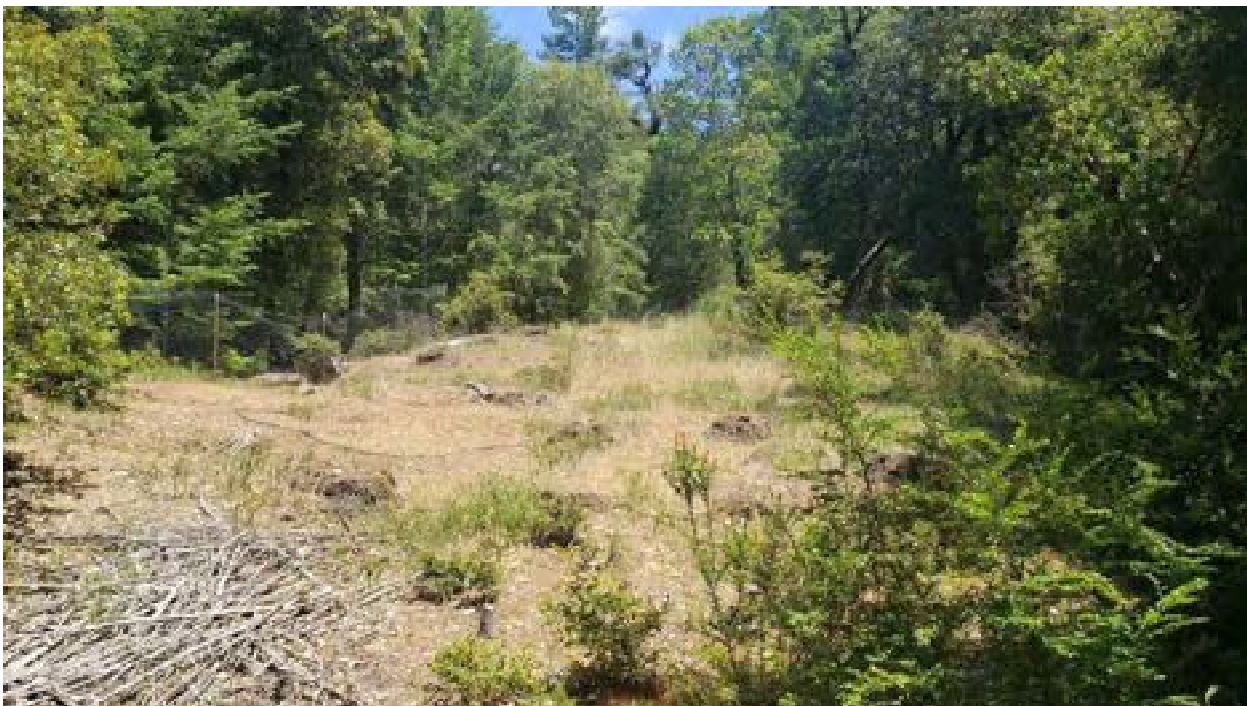
Looking up grade at OG1.

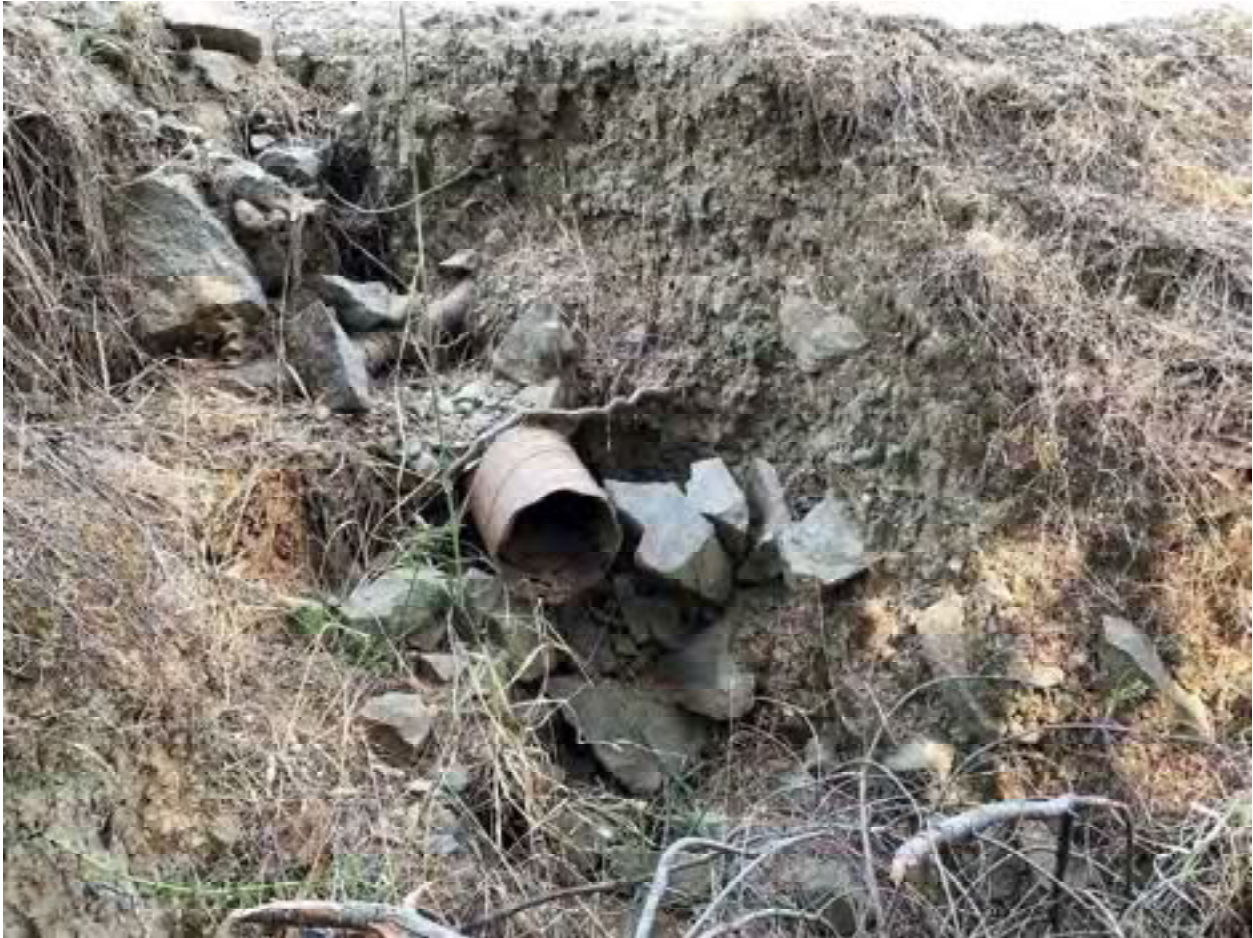
**Photo 33:** Stream Crossing 08. Looking upstream towards the outlet of the 8-inch diameter culvert at stream crossing 08. Photo date 9-1-2021.

| Project Site Identification | Estimated Completion Date |
|---|---|
| SC-8 | Replace existing 8-inch diameter culvert with minimum 18-inch diameter culvert set to grade. Rock armor inlet and outlet as necessary to minimize potential erosion. The proposed work shall be completed by no later than October 31, 2025. |

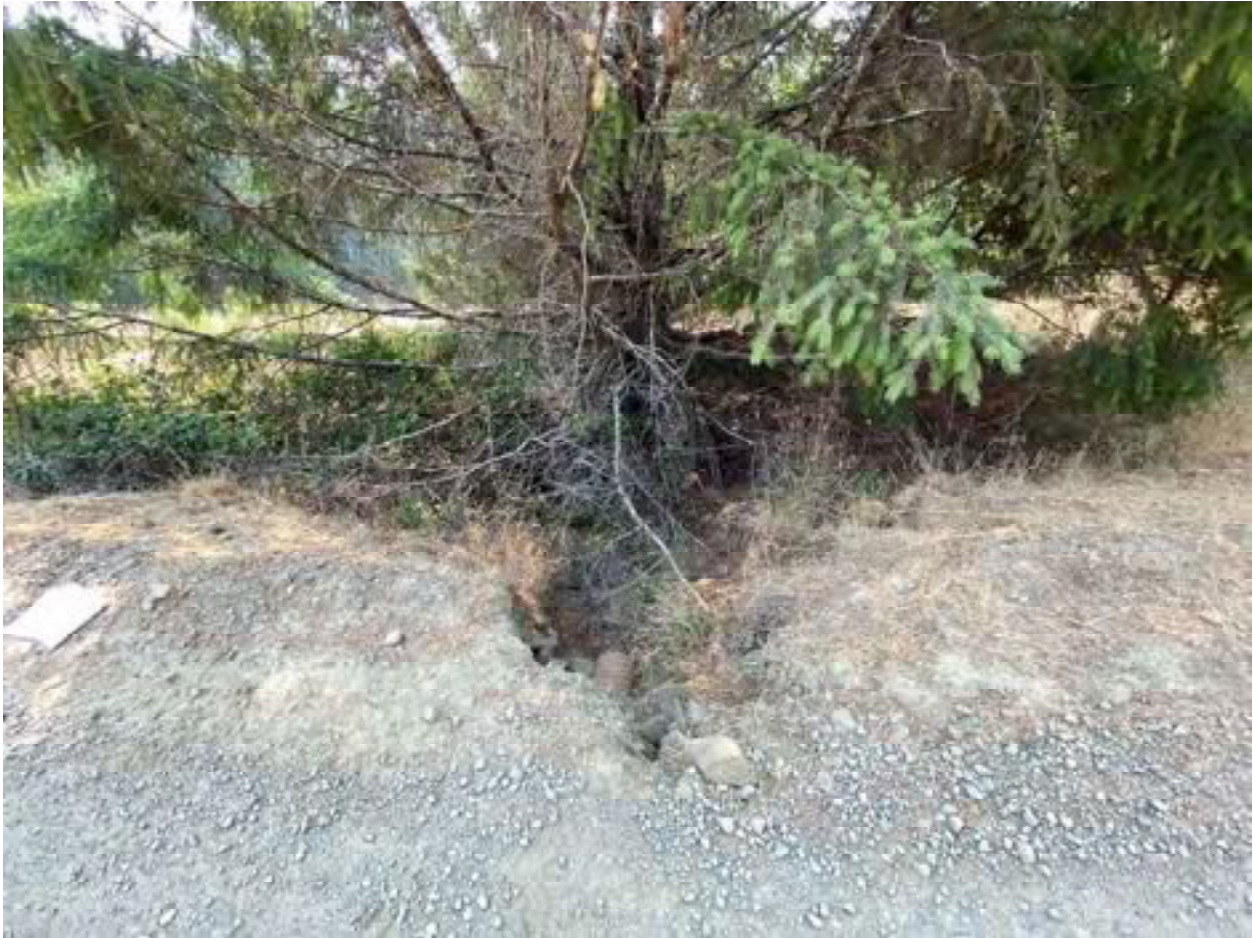
**Photo 34:** Stream Crossing 08. Looking downstream from the outlet of the 8-inch diameter culvert at stream crossing 08. Photo date 9-1-2021.

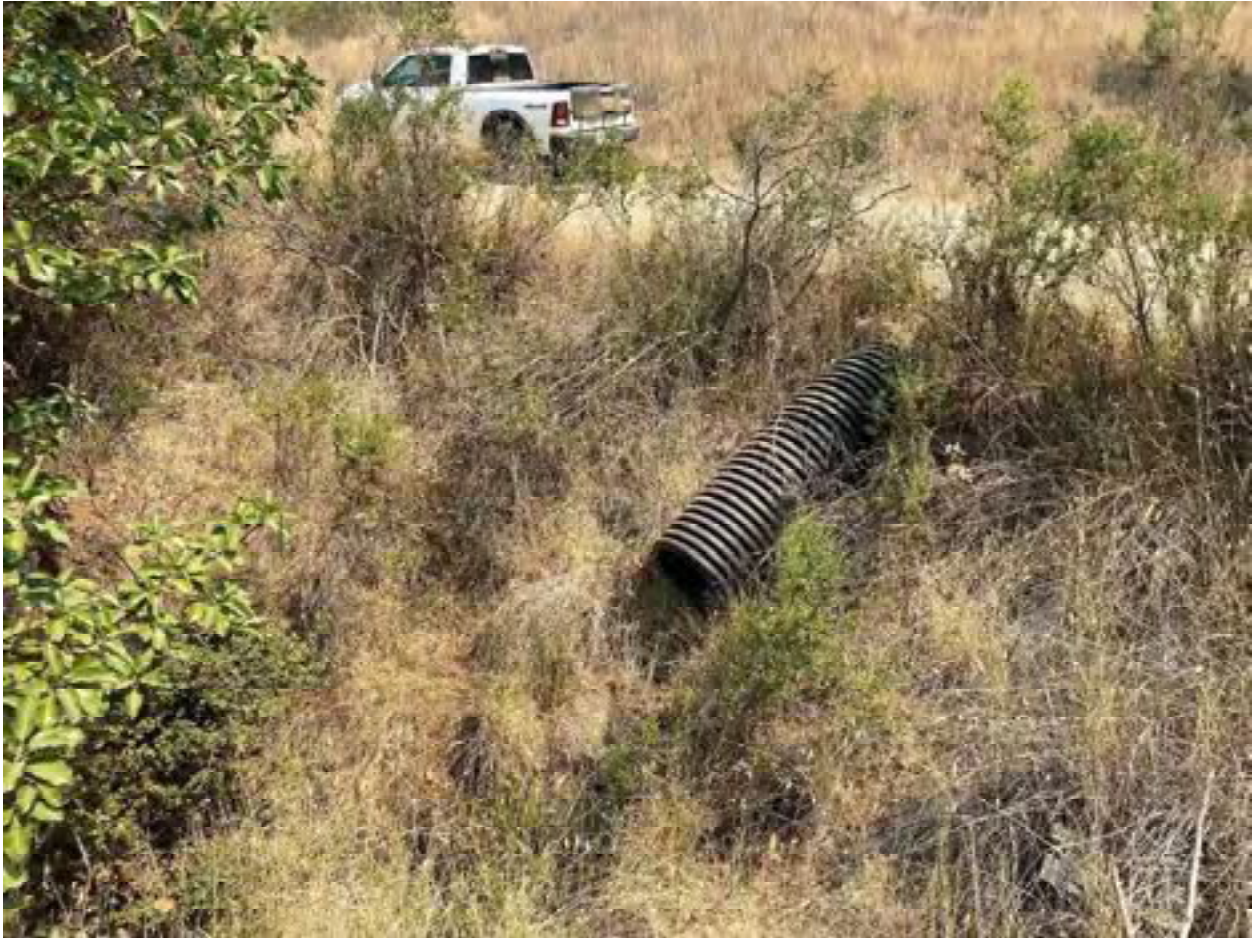
**Photo 38:** Stream Crossing 11. Looking towards the outlet of the 24-inch diameter culvert at stream crossing 11. Photo date 9-1-2021.

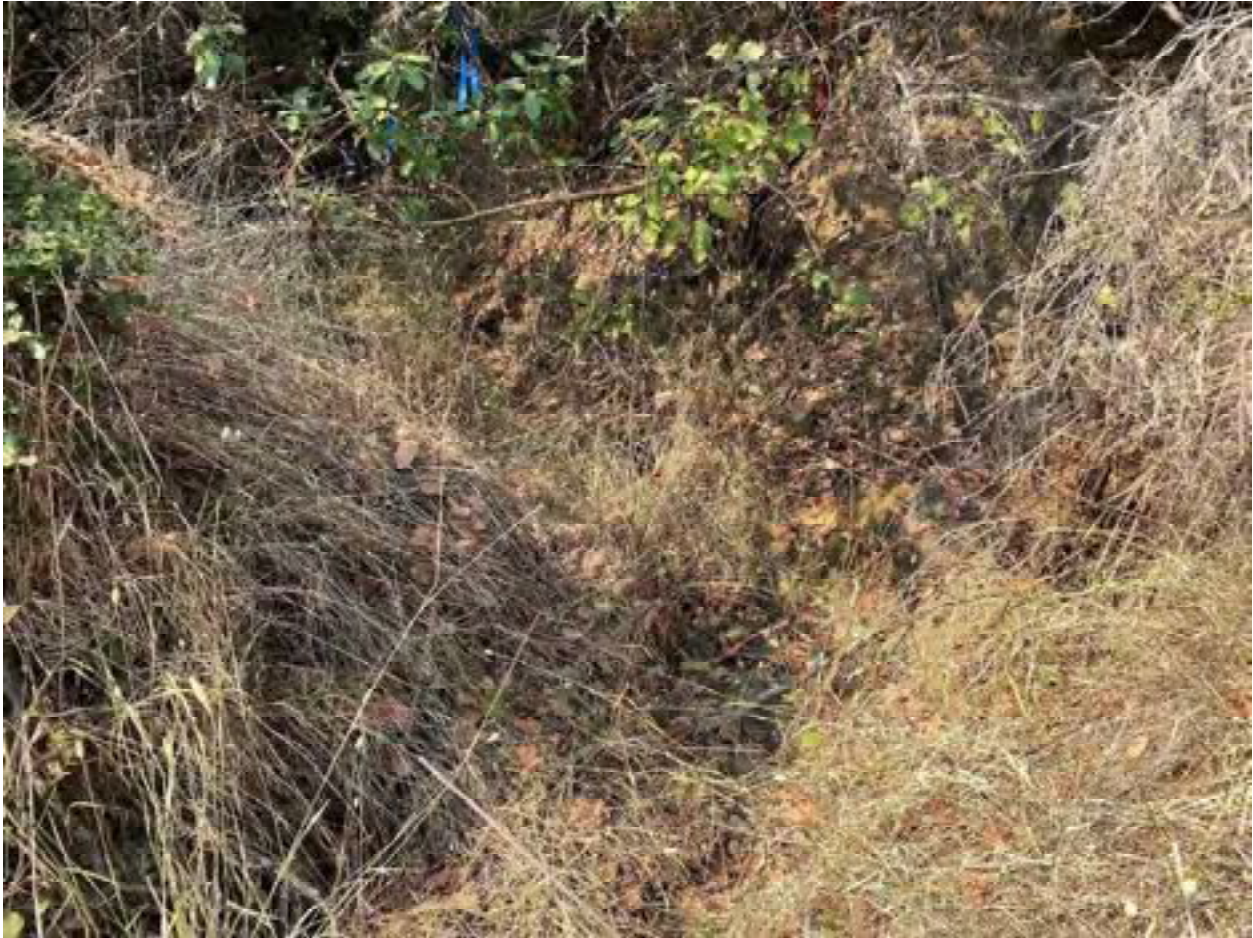
**Photo 39:** Stream Crossing 11. Looking downstream from the outlet of the 24-inch diameter culvert at stream crossing 11. Photo date 9-1-2021.

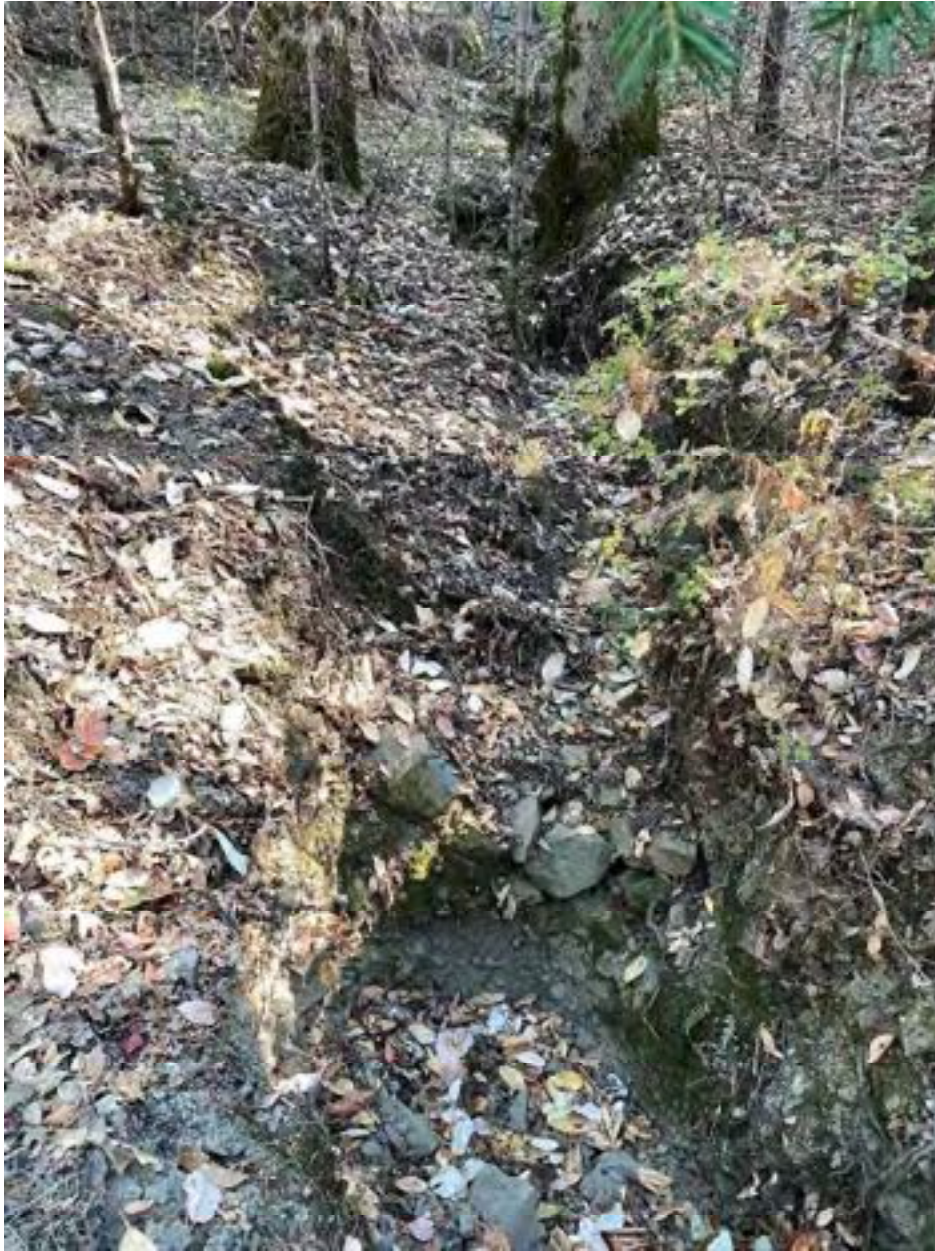
**Photo 48:** Stream Crossing 17. Looking upstream from the inlet of the 18-inch diameter culvert at stream crossing 17 that is proposed for removal. Photo date 9-1-2021.

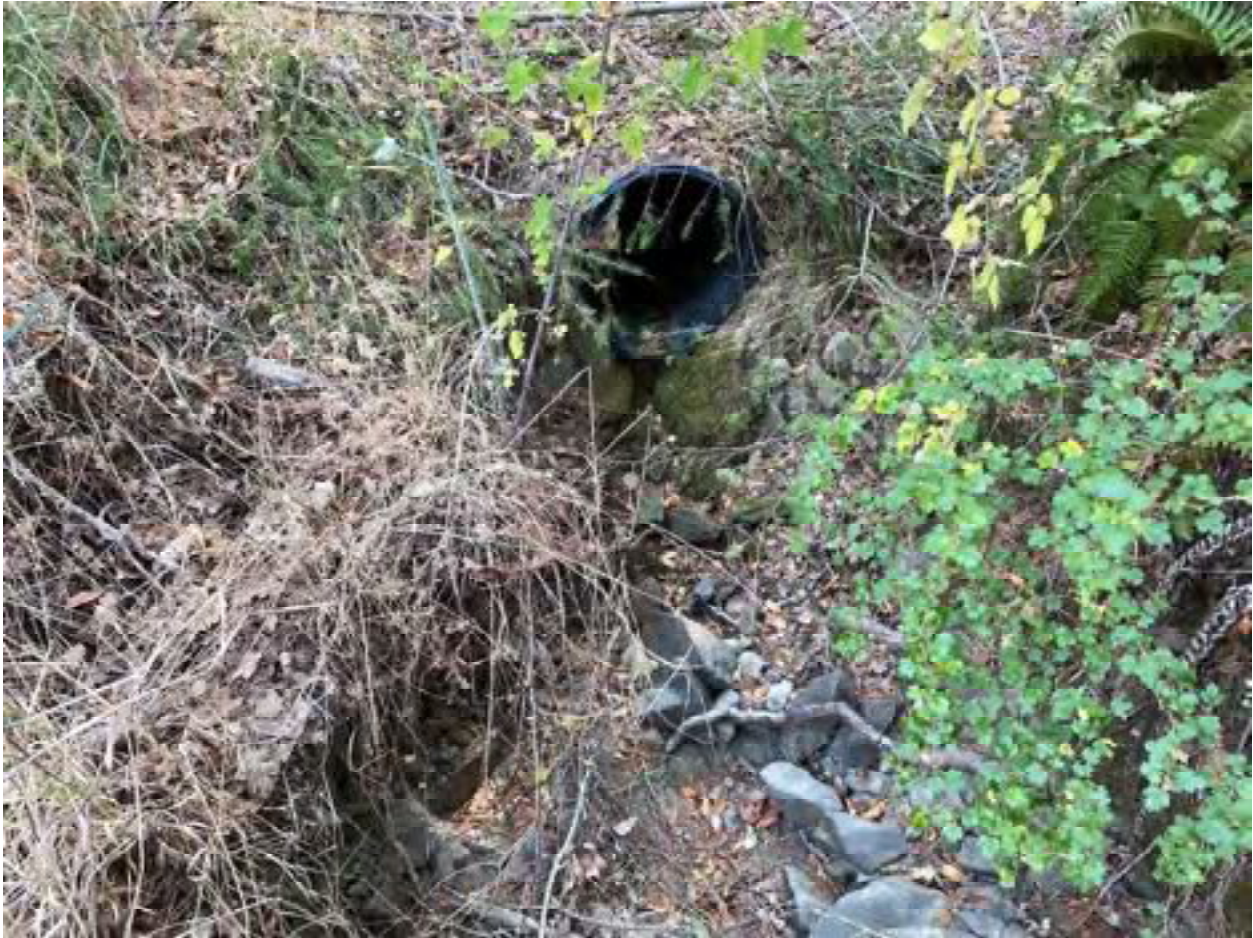
**Photo 55:** Stream Crossing 19. Looking upstream towards the outlet of the 18-inch diameter culvert at stream crossing 19. Photo date 9-1-2021.

| Project Site Identification | Estimated Completion Date |
|---|--|
| SC-19 | An existing, misaligned, and failing 18-inch culvert on an abandoned road shall be removed and the road decommissioned. The crossing shall be realigned to match with the native channel. This is a site of remediation. The proposed work shall be completed by no later than October 31, 2023. |

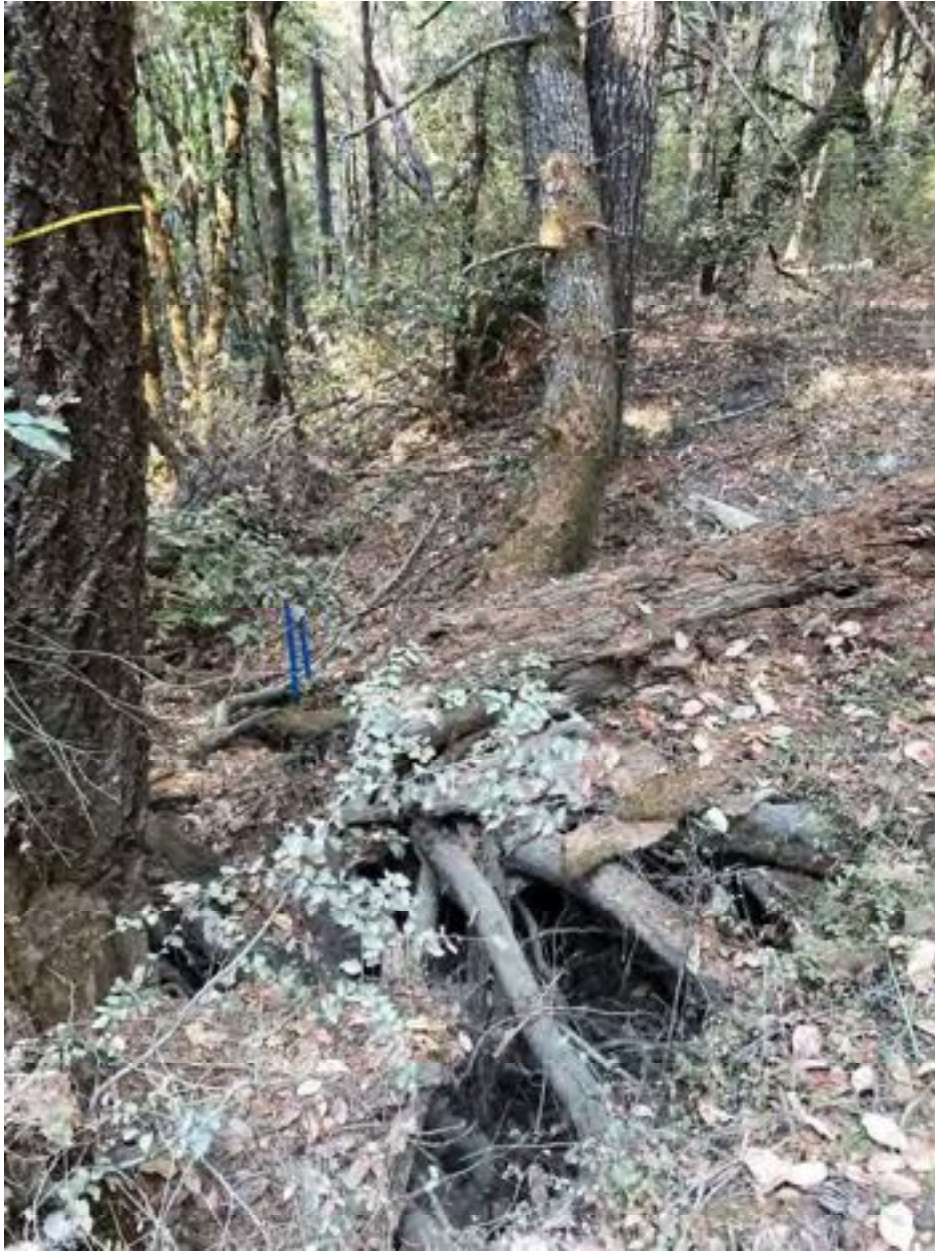
**Photo 67:** Stream Crossing 24. Looking downstream from the outlet of the 18-inch diameter culvert at stream crossing 24. Photo date 9-1-2021.

| Project Site Identification | Estimated Completion Date |
|---|--|
| SC-24 | Replace an existing 18-inch diameter culvert with a minimum 36-inch diameter culvert set to grade. Rock armor the inlet and outlet as necessary to minimize potential erosion. The proposed work shall be completed by no later than October 31, 2024. |
